**LIGHTHOUSE HARBOR CONDOMINIUMS  
NEW ORLEANS, LA**

**ELEVATOR MODERNIZATION SURVEY**

**MARCH 26, 2026**

LB Project No 0100063175

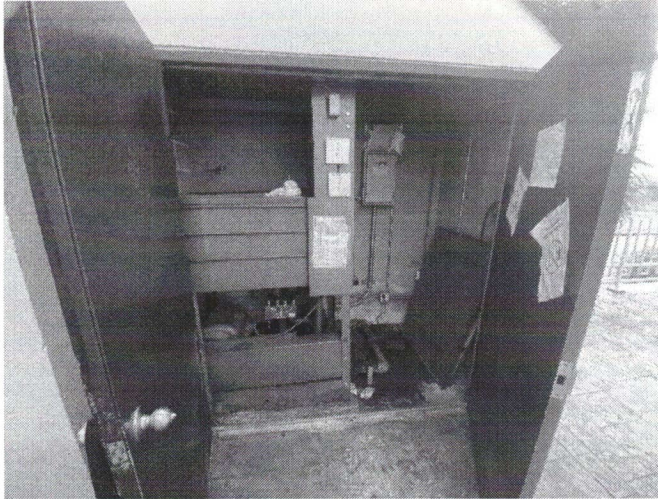
1. South – Elevator equipment room

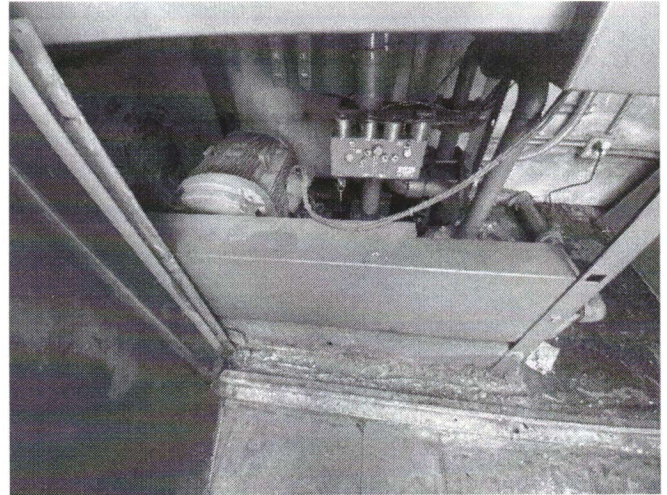
2. South – Power unit pump motor and Dover I-2 Valve.

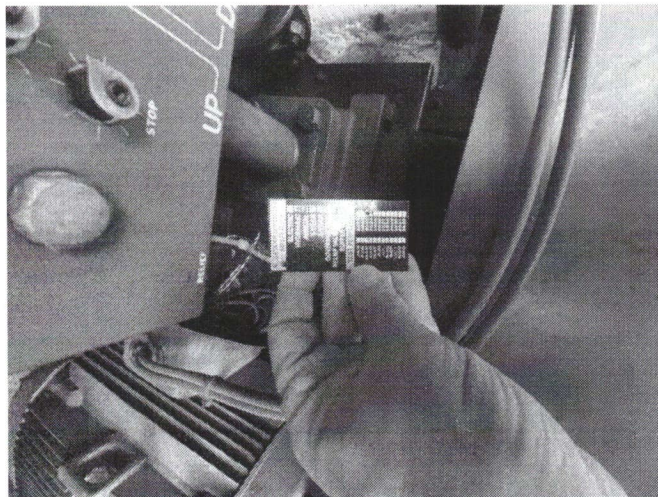
3. South – Relief pressure test past due.

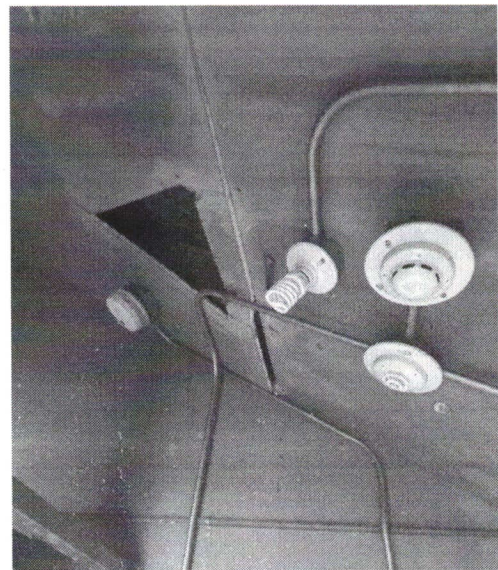
4. South – New machine room lighting should be installed to meet code requirements. Machine room sheet rock should be repaired.

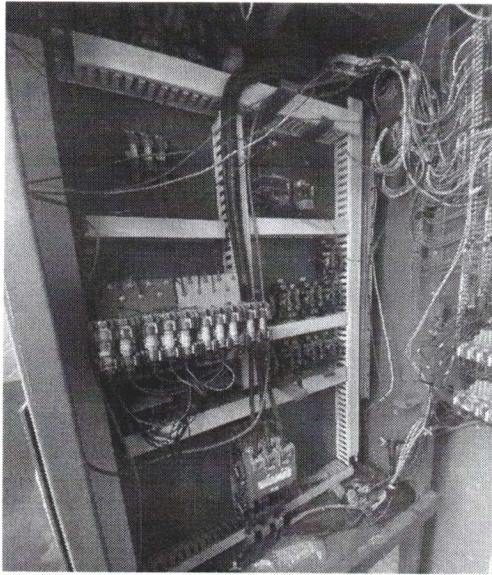
5. South – Dover solid state controller – Obsolete.

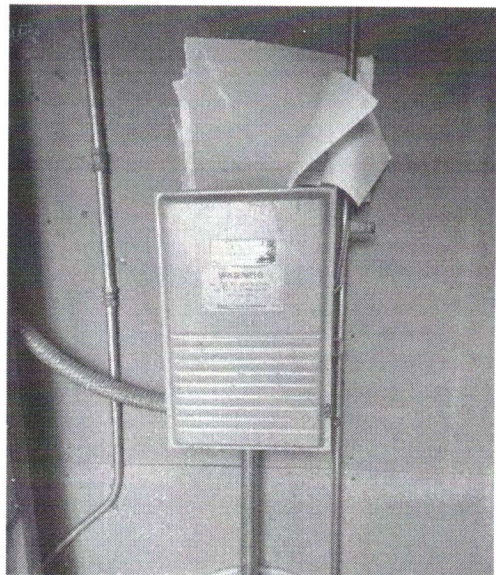
6. South - New lockable mainline disconnect switch should be provided. (typical)

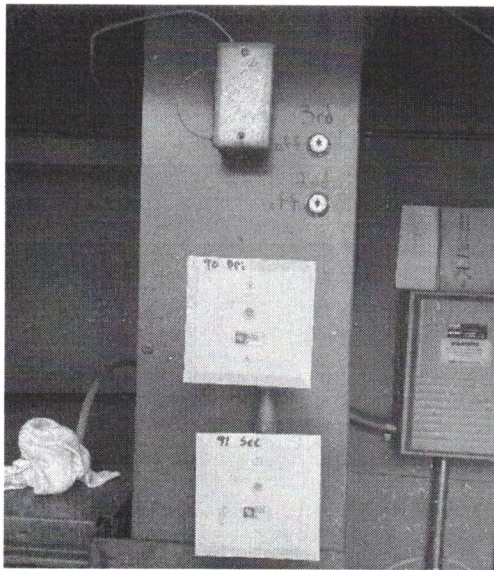
7. South - Additional Fire Hat Fire Recall relays must be added to meet conde compliance. (typical)

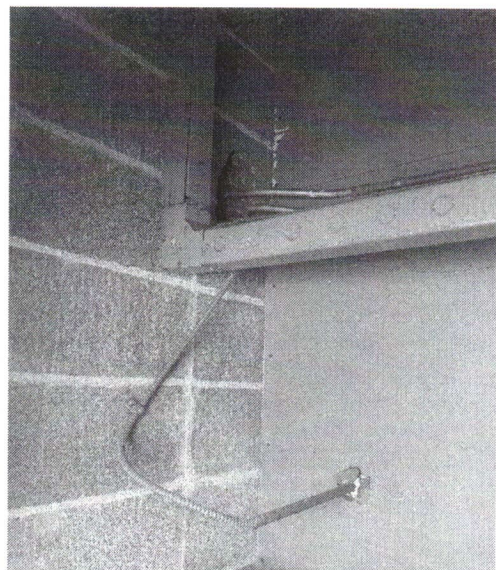
8. South - Machine room penetrations must be repaired and wiring properly run in conduit as required.

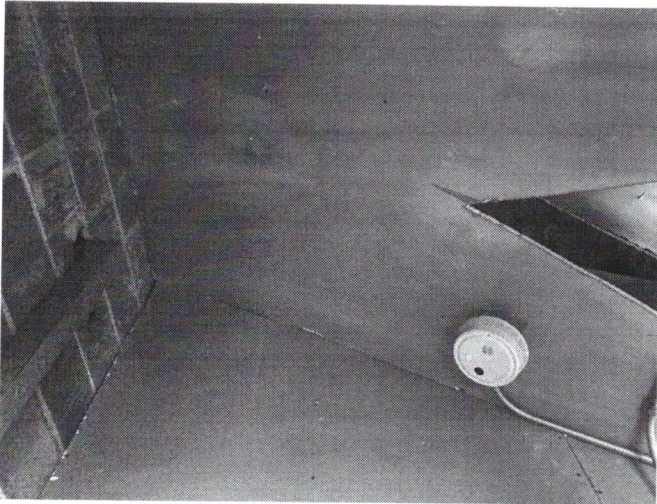
9. South - Machine room sheetrock should be properly sealed for code compliant fire rating.

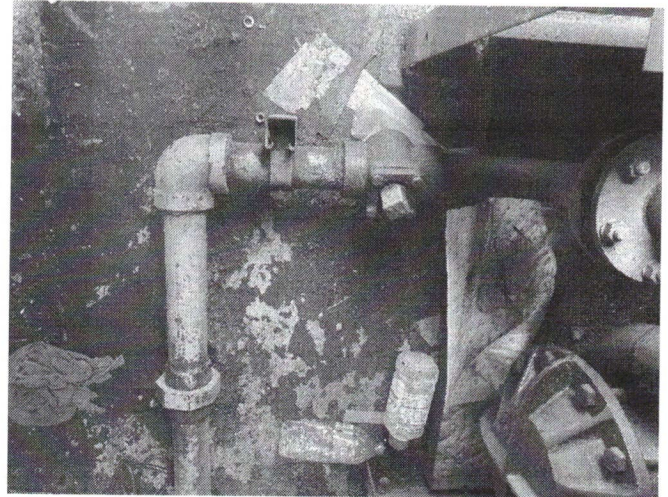
10. South - A new machine room shut off valve will be required.

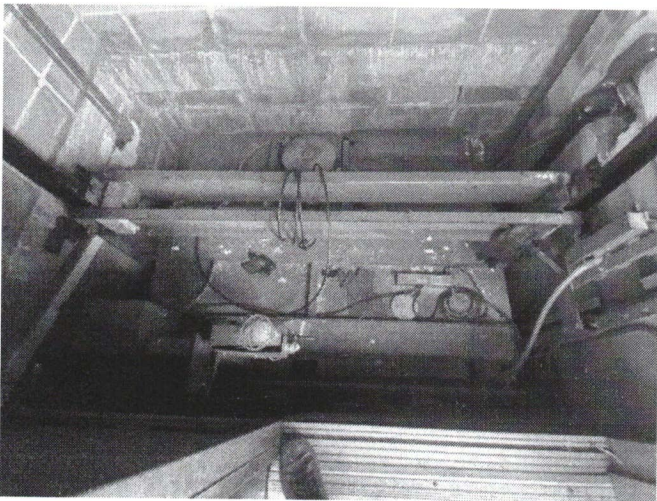
11. South - All new car top equipment should be provided.

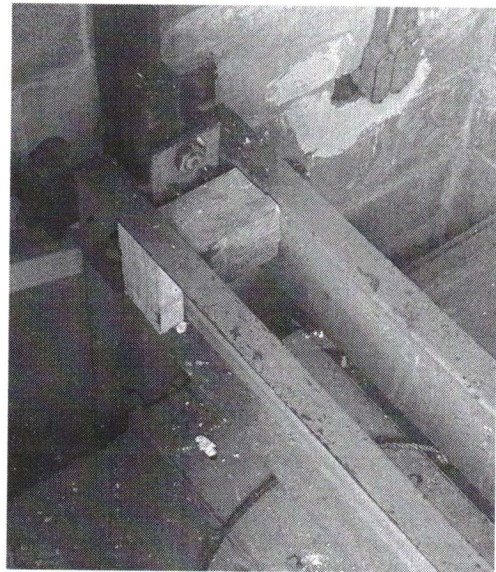
12. South - Crosshead should be inspected for necessary repair or replacement.

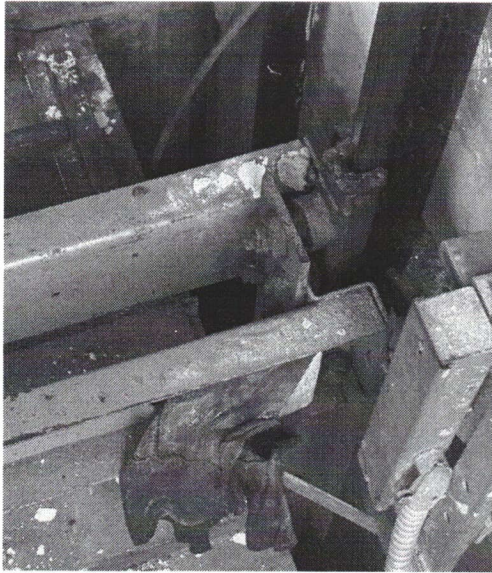
13. South - New car slide guides are recommended for replacement.

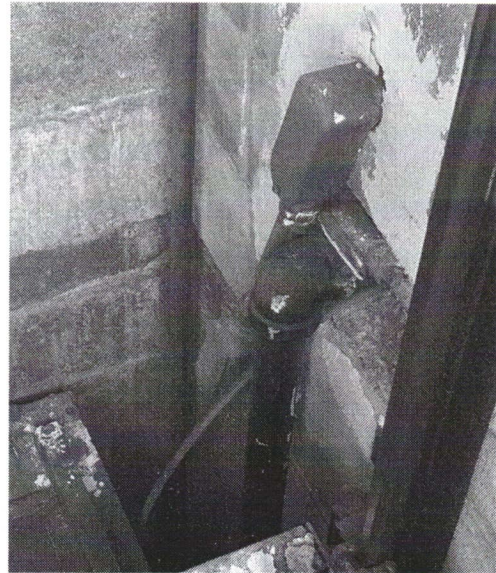
14. South - Hoistway penetrations should be properly sealed.

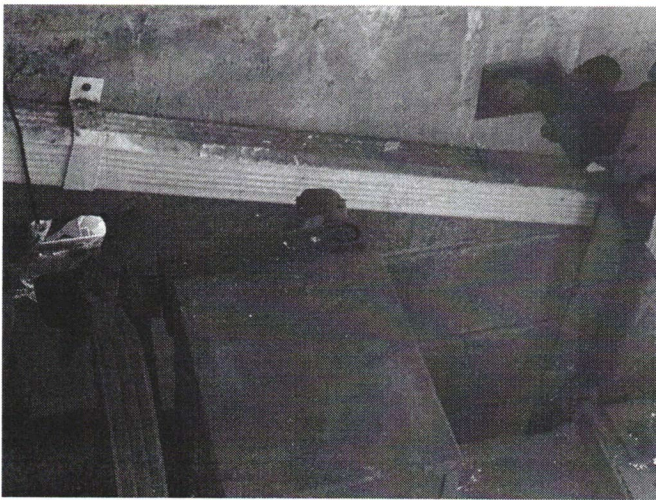
15. South - Gutter material at each landing should be removed.

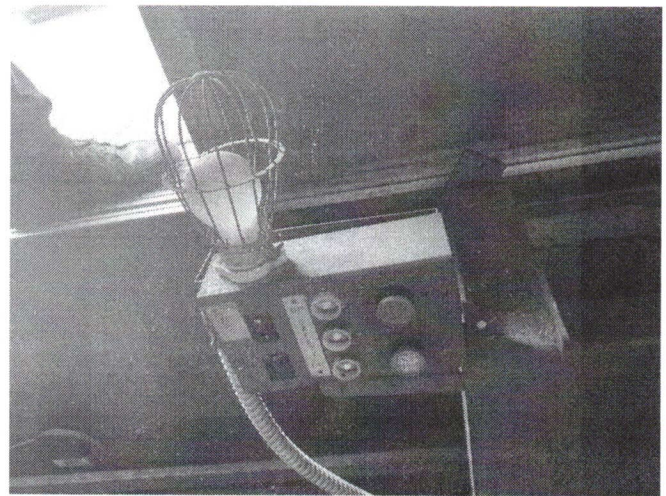
16. South – New car top inspection station should be installed.

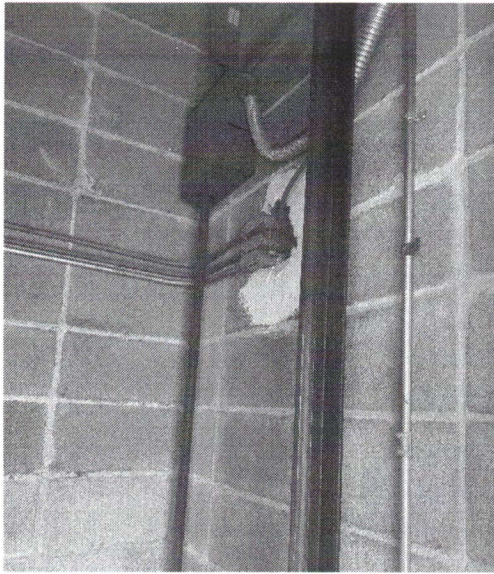
17. South - Hoistway penetrations should be properly sealed.

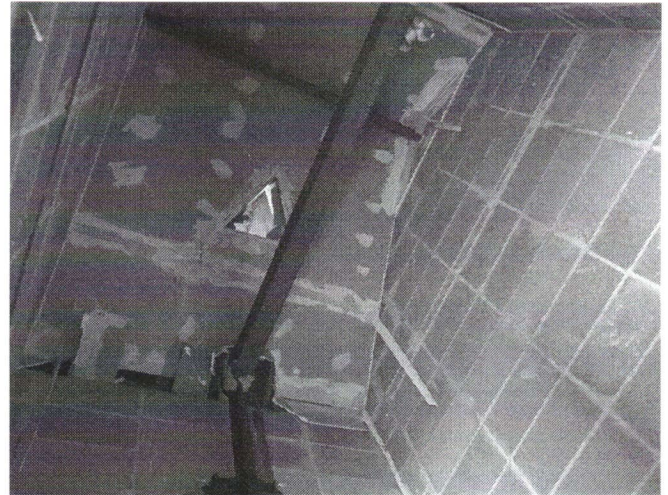
18. South – Sheetrock at top of hoistway should be properly repaired.

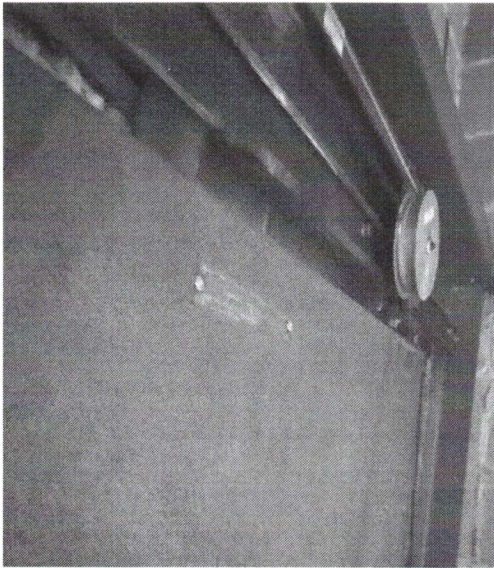
19. South – New hoistway door tracks and hangers should be replaced due to rusted condition.

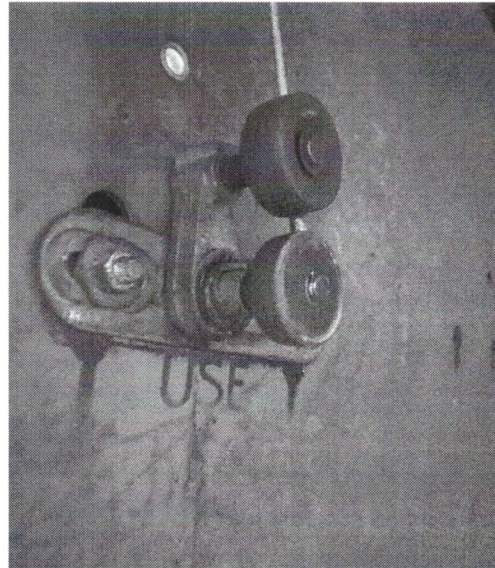
20. South – New hoistway door equipment should be replaced due to condition.

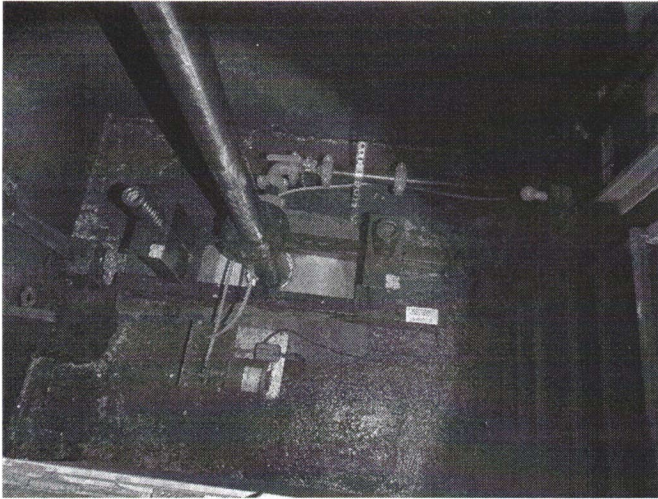
21. South – Elevator pit is wet with accumulated water.

Waterproof pit, if wet conditions exist. Sump pump and drain is required to function as designed and intended.

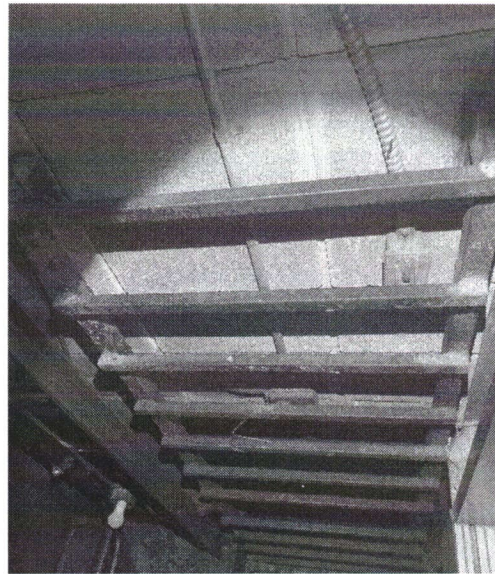
22. South – New code compliant pit access ladder should be installed.

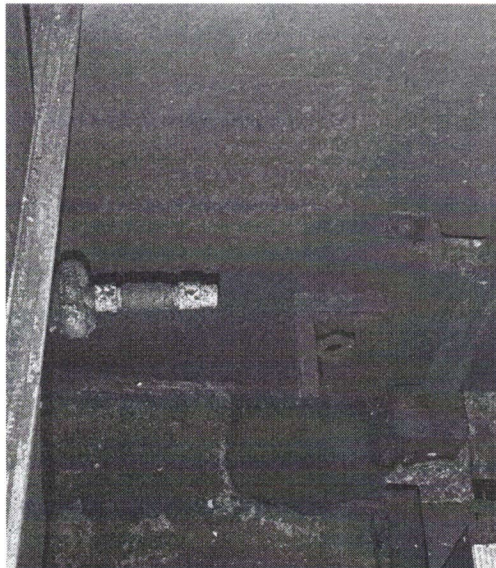
23. South – Pipe protruding into the elevator pit should be removed and rerouted.

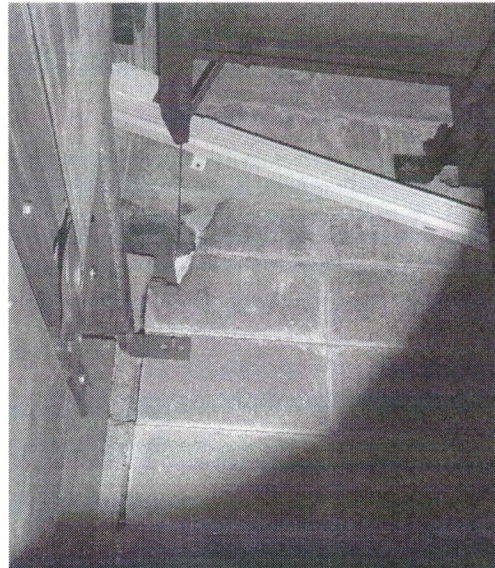
24. Damaged block in the elevator hoistway must be repaired.

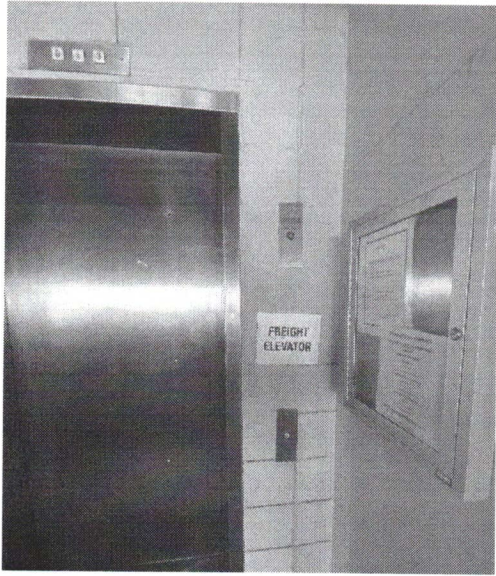
25. South – New vandal-resistant corridor fixtures are recommended.

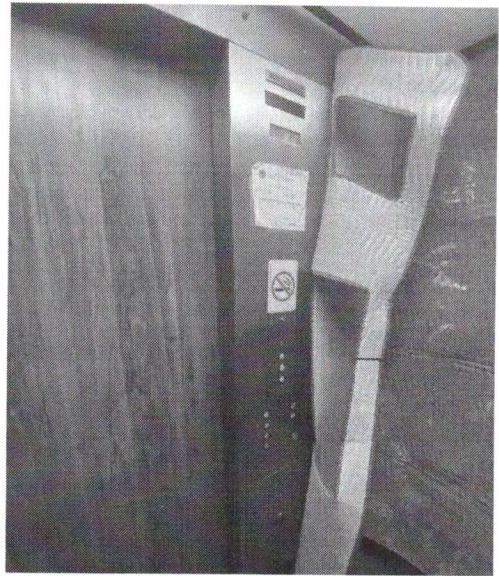
26. South – A new car operating panel with vandal-resistant buttons and operational switches and signals to be provided.

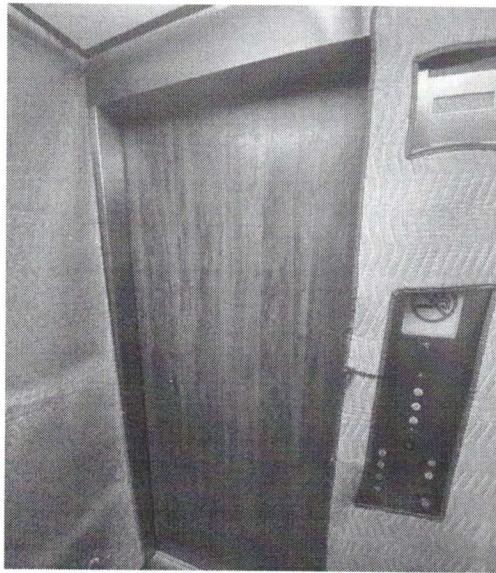
27. South – New stainless steel cab doors will be installed.

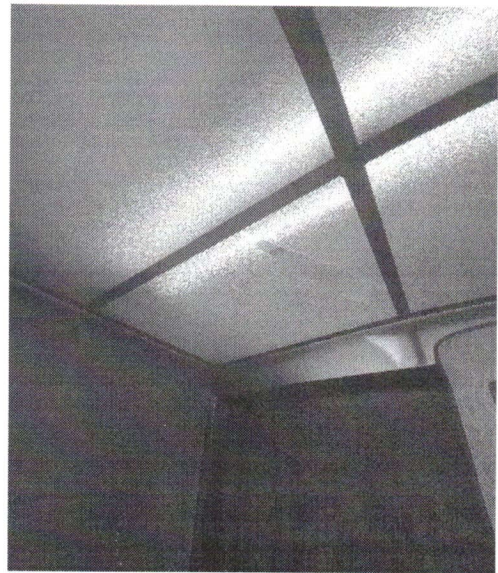
28. South - A new suspended ceiling with LED lighting and code compliant lighting diffuser panels should be installed.

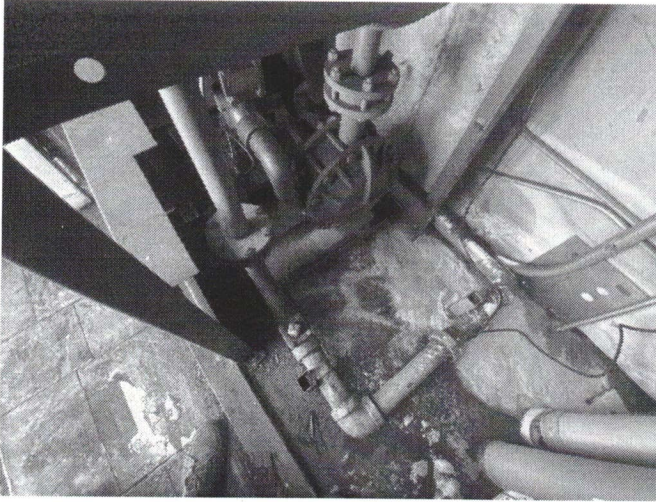
29. North – A new machine room shut-off valve must be installed.

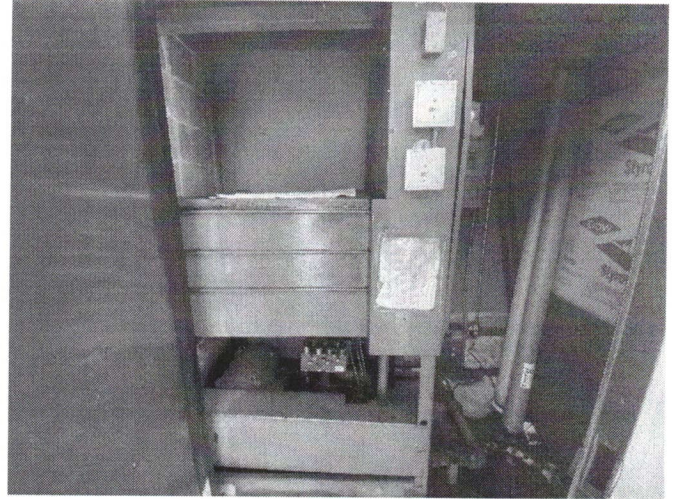
30. North – Elevator equipment room with power unit and controller – This equipment is obsolete and in poor condition.

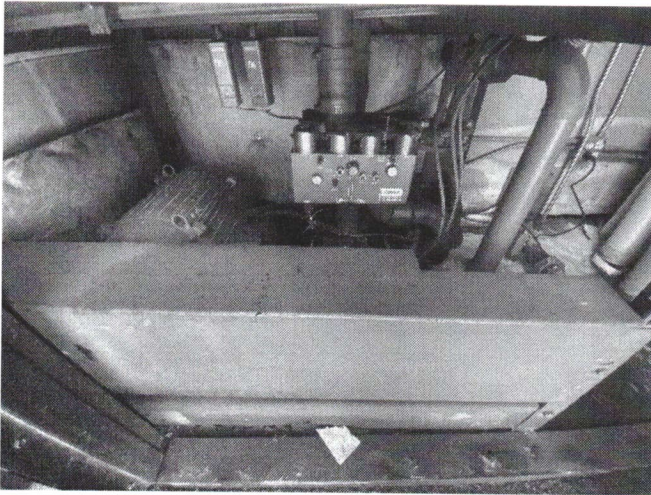
31. North – Power unit pump motor and Dover I-2 valve. This unit is in poor condition with several leaks. These leaks are leaking onto the overhang on the "G" level.

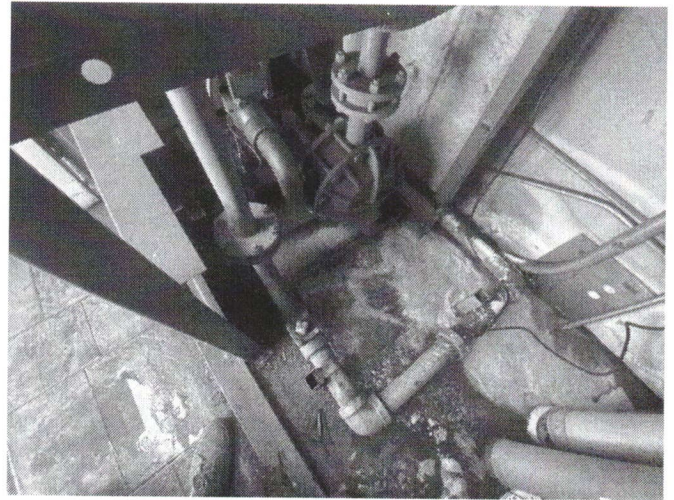
32. North – A new machine room shut-off valve must be installed.

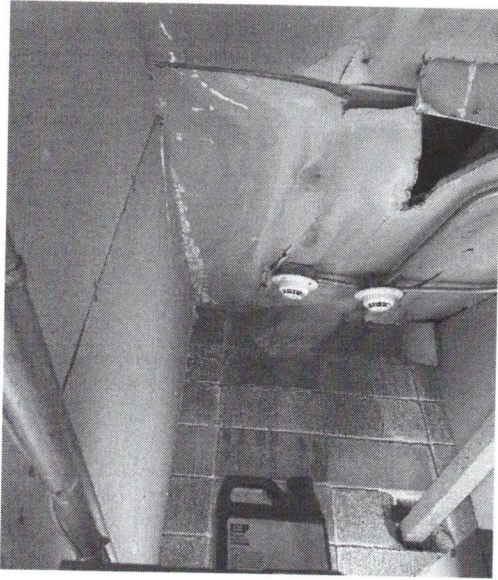
33. The machine room sheet rock ceiling must be repaired.

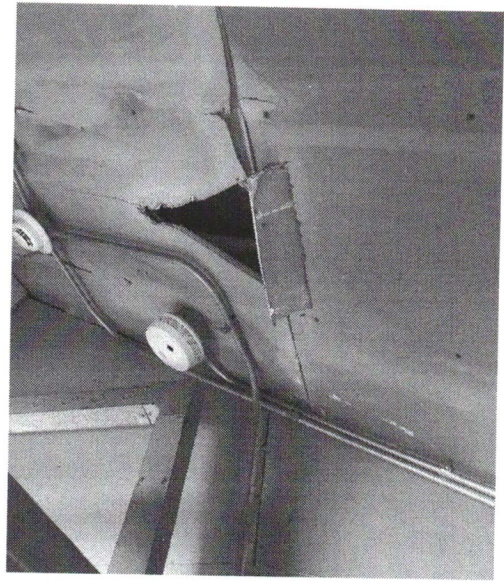
34. The machine room sheet rock ceiling must be repaired.

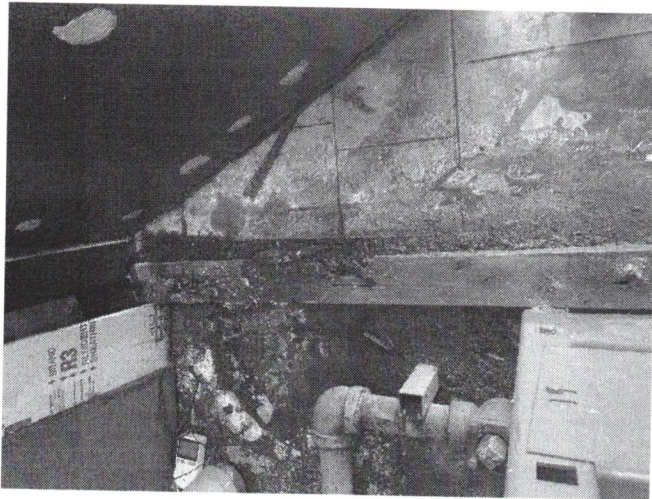
35. North – Machine room threshold must be replaced.

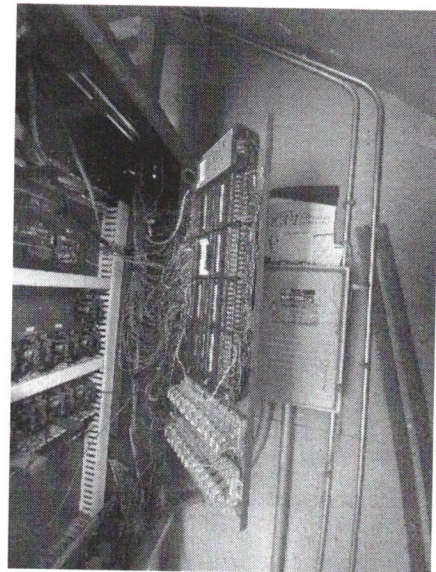
36. North – Dover solid state controller with relay modernization. - Obsolete

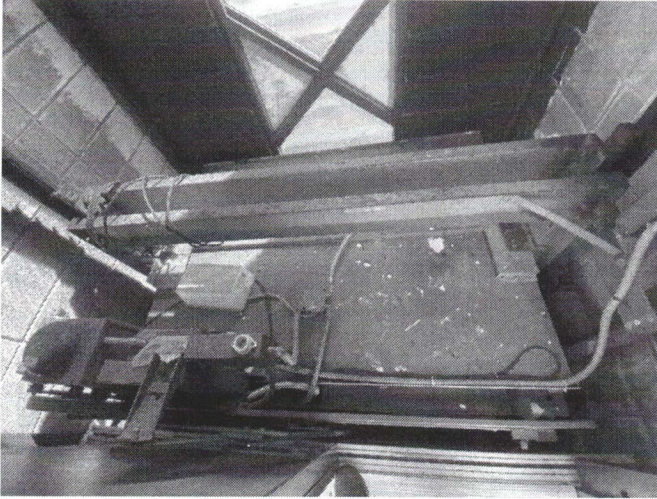
37. North – All car top equipment to be recommended for replacement.

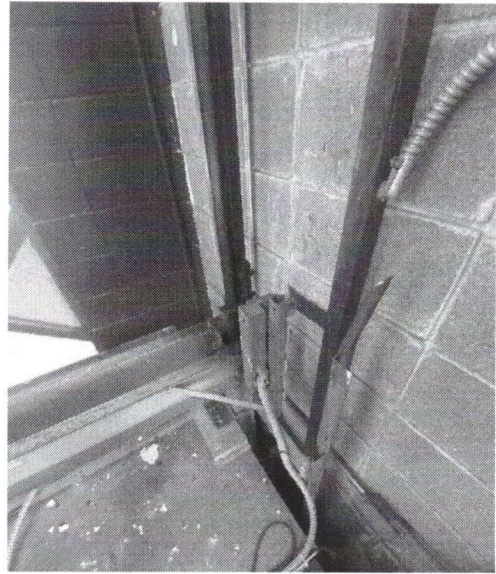
38. North – New car positioning device to be installed.

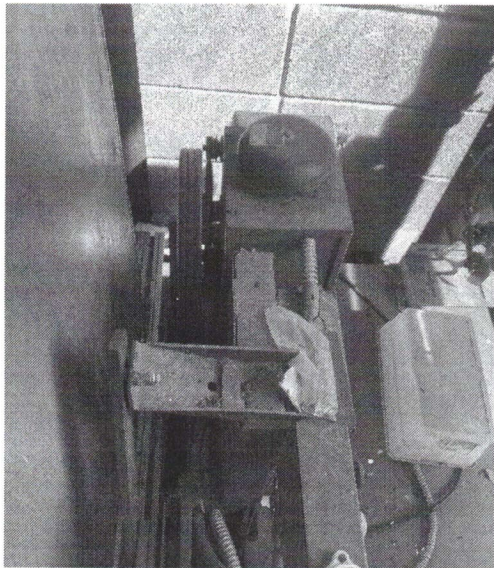
39. North – New door operator to be installed.

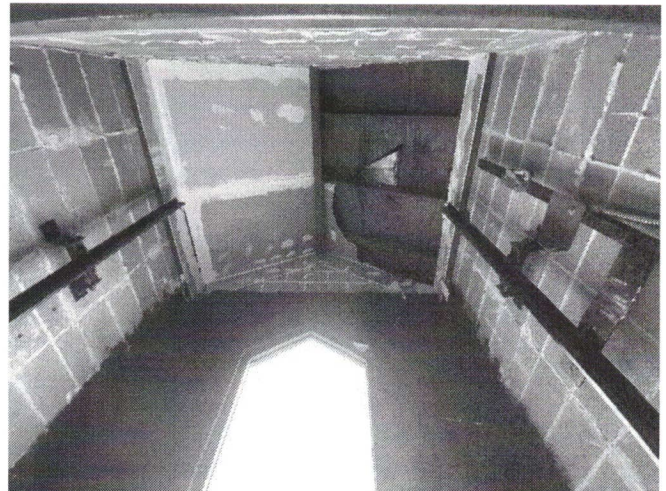
40. North – Sheetrock at top of elevator hoistway must be repaired for proper fire rating.

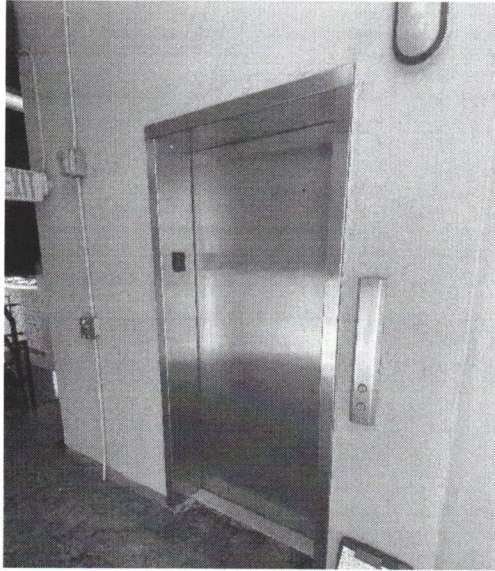
41. North – Corridor button fixtures to be replaced with vandal-resistant fixtures.

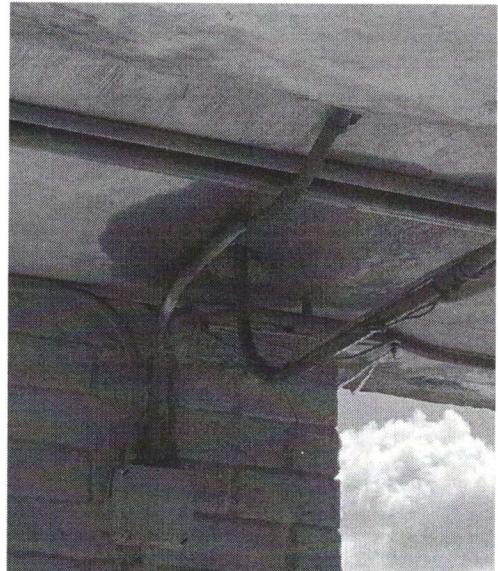
42. North – Leaking power unit is penetrating through the machine room floor onto the building overhead on the "G" level.
