## Repair Recommendations

A site visit was conducted from March 9 – 12, 2026, with site observations performed by Lesley Horst, P.E., Senior Consultant, and Traci Powell, P.E., Senior Consultant, with Lerch Bates. In addition to Lerch Bates, representatives of C/Sharpe were present to assist with destructive openings for observation of concealed conditions.

## Observations

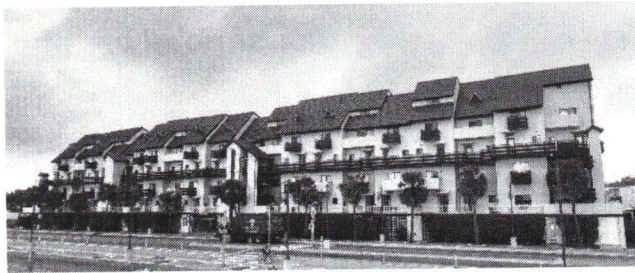
**Figure 1:** Overall view of the east elevation.

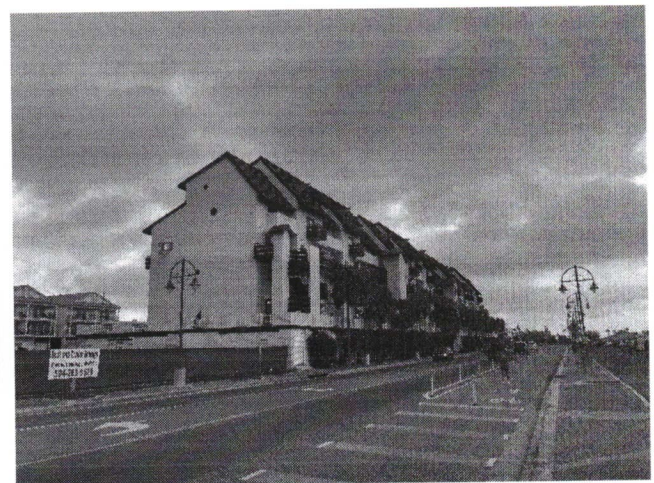
**Figure 2:** View of the south elevation.

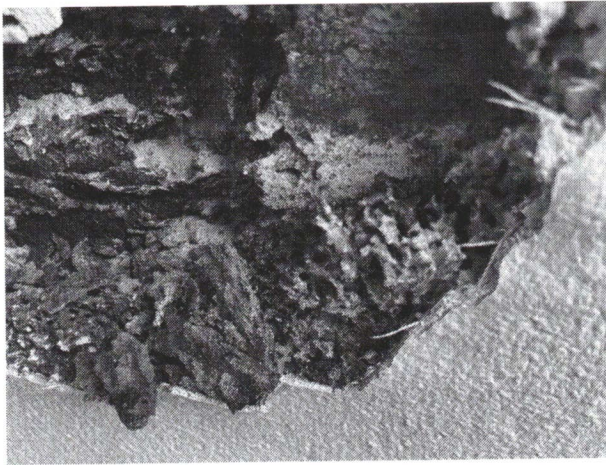
**Figure 59:** View of significant deterioration of studs, sheathing, and insulation within the Stair #2 spandrel wall.

- The Stair #2 (south) EIFS spandrel wall was observed to be severely deteriorated with section loss of the concealed cold-formed metal framing and sheathing elements. The foam insulation was observed to be eroded and deteriorated. The wall should be reconstructed to restore structural integrity along the east stair perimeters (Figures 56 through 59).

- S-1** Remove and replace Stair #3 (north) and Stair #1 (center) in their entirety and Stair #2 (south) from ground floor to Level 1. Implement spot steel repairs to Stair #2 where needed from Level 1 to Level 3.
- S-2** Perform steel repairs at isolated locations of steel corrosion at spiral stair rail bases.
- S-3** Perform spiral stair steel coating restoration, including cleaning surface corrosion where present.
- S-4** Demolish and reconstruct the EIFS Stair #2 east perimeter wall to restore the structural integrity of the stair rail/wall.
