# INSPECTION OF STAIRWELLS AND 3<sup>rd</sup> FLOOR WALKWAYS FOR LIGHTHOUSE HARBOR CONDOMINIUMS

*October 3, 2022*

Larry M. Oliver Enterprises, Inc. was charged with the task of inspecting the existing stairwells and 3<sup>rd</sup> Floor walkways located at 7300 Lakeshore Drive New Orleans, Louisiana, for Lighthouse Harbor Condominiums.

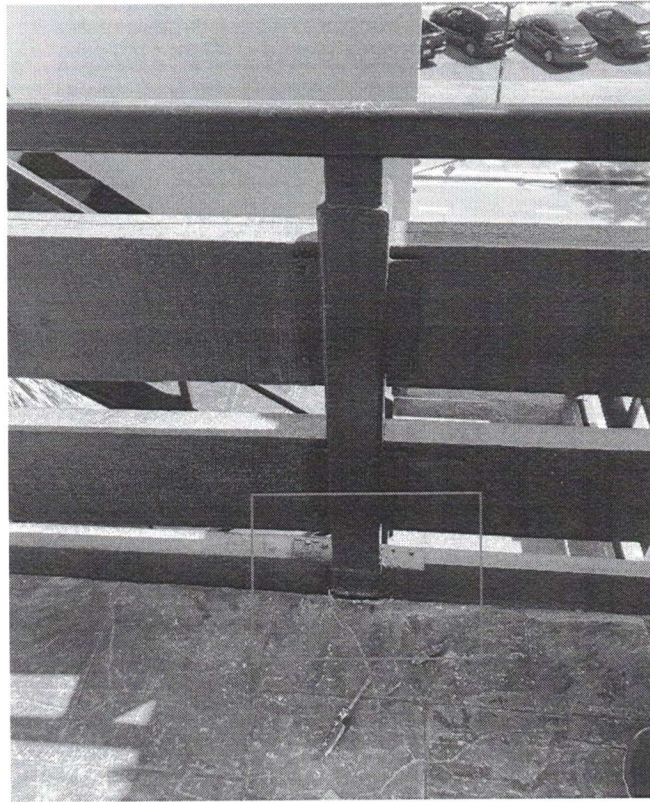
**Photo No. 1 – South Stairwell Column Repair Location No. 1**

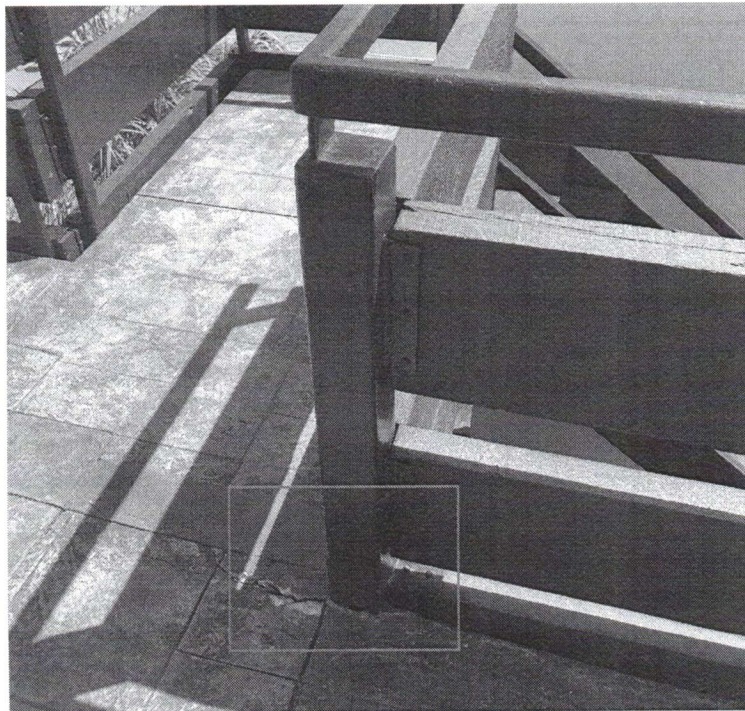
**Photo No. 2 – South Stairwell Column Repair Location No. 2**

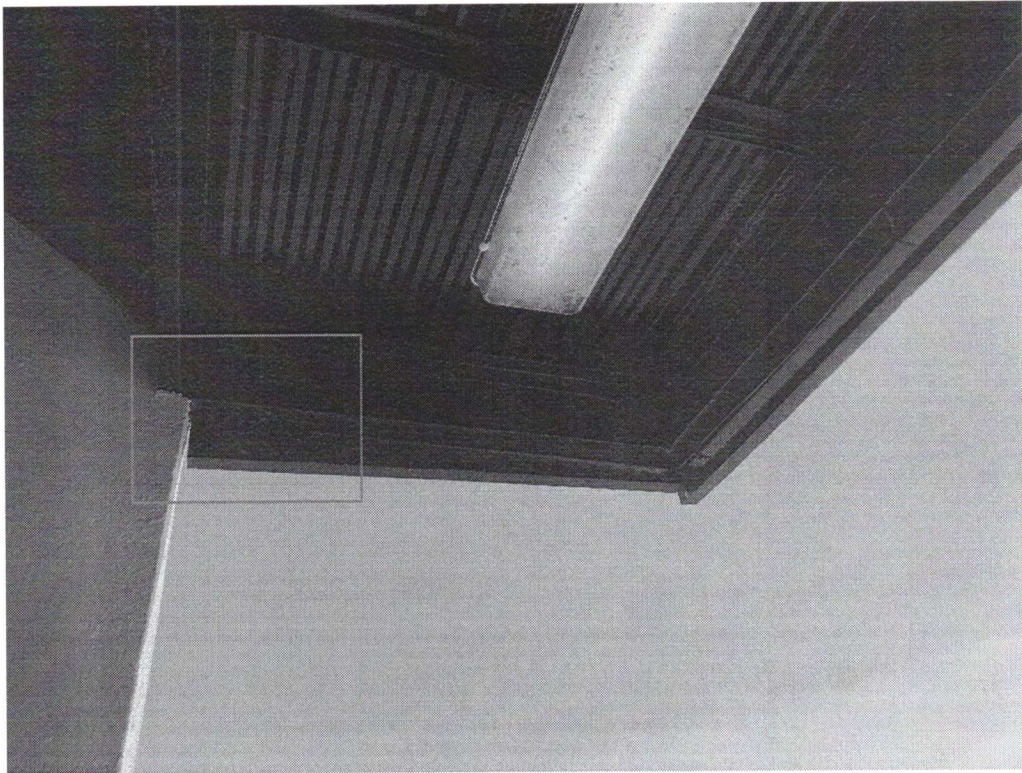
**Photo No. 3 – South Stairwell Type I Repair**

**Type I** category metal show signs of paint flaking and rusting on the member. The rust shall be removed by wire brush or mechanical method. These are to be cleaned, primed, and two finish coats applied as stated in sections below.

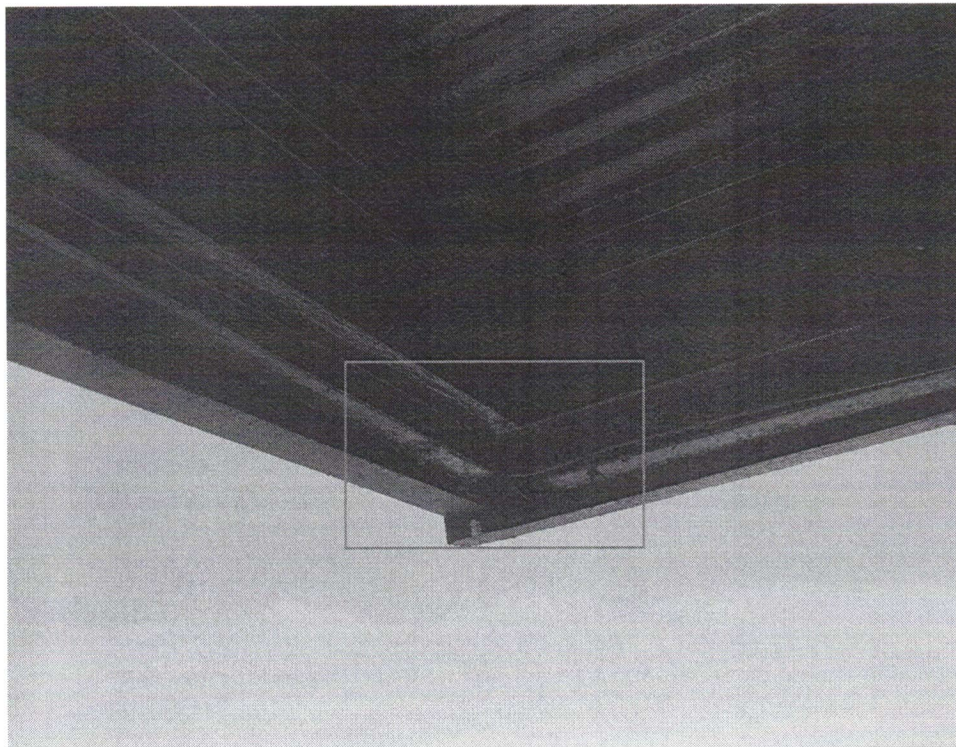
**Photo No. 4 – South Stairwell Type I Repair**

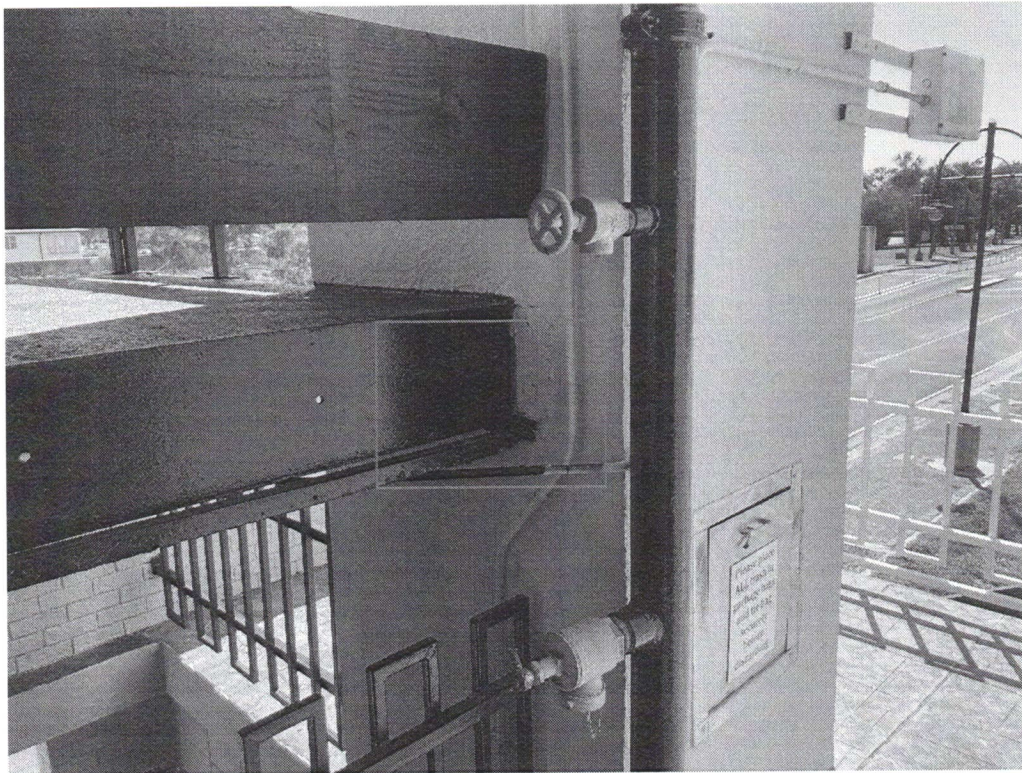
**Photo No. 5 – South Stairwell Type I Repair**

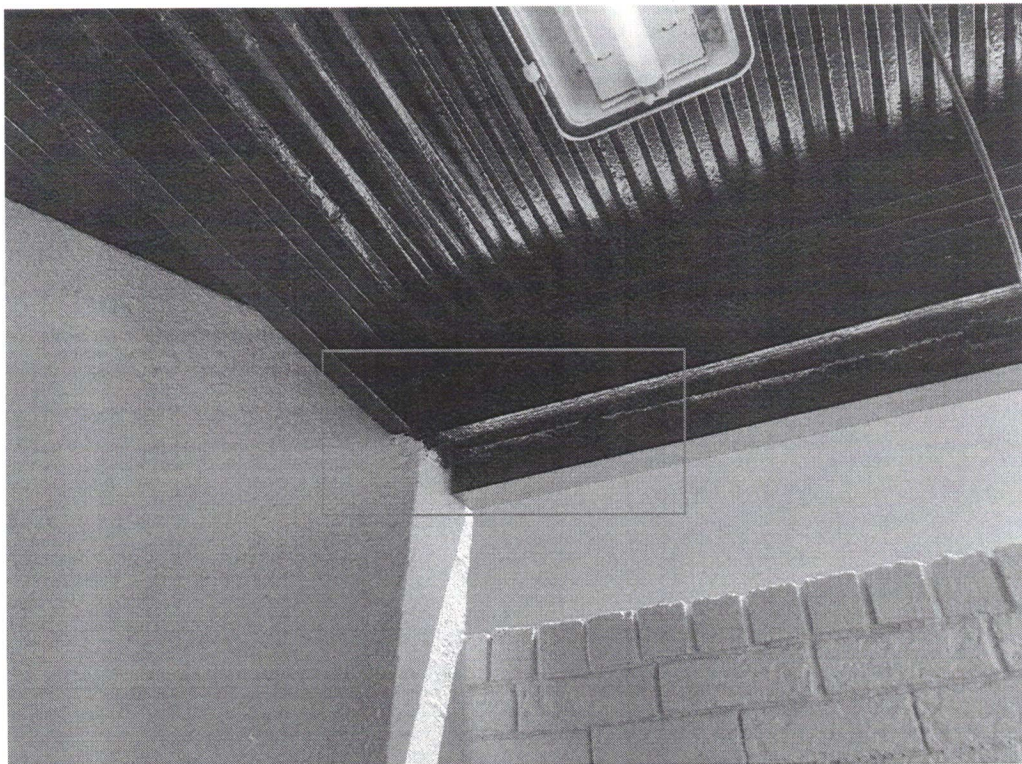
**Photo No. 6 – South Stairwell Type I Repair**

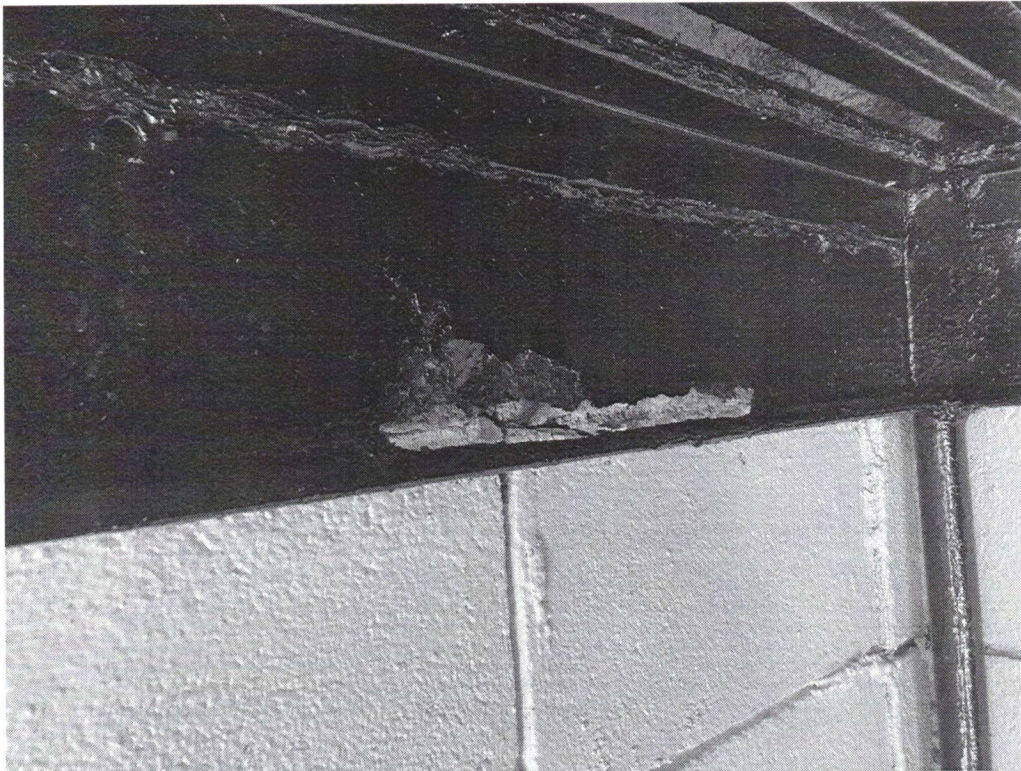
**Photo No. 7 – South Stairwell Type II Repair**

**Type II** category metal has significant loss of member due to advanced corrosion on the member. The rust shall be moved by mechanical method until sound metal is found at its original thickness. These are to be repaired by welding a splice plate of equal or greater thickness than the existing member to the sound metal. New splice shall be cleaned, primed, and two finish coats applied as stated in sections below.

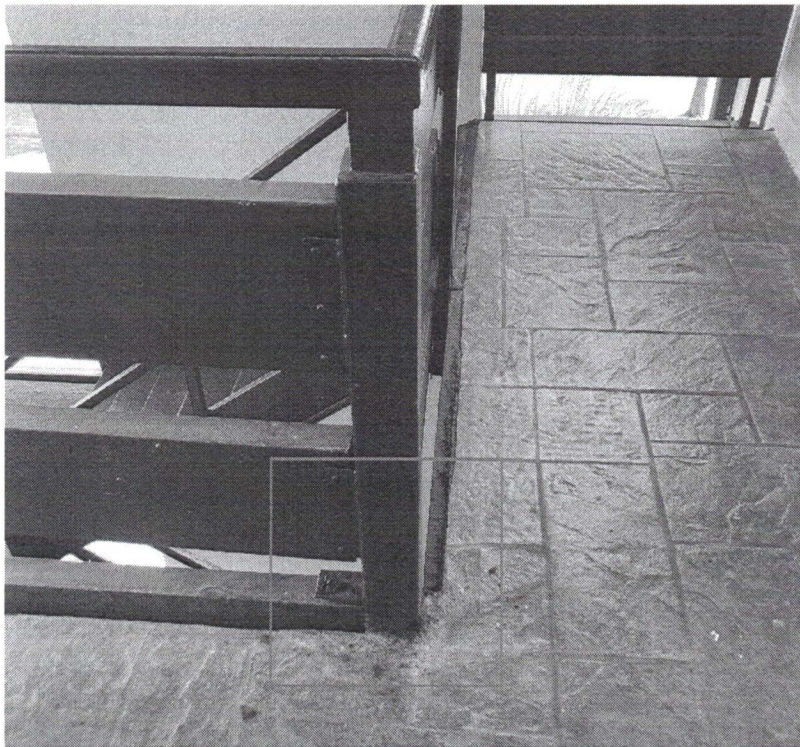
**Photo No. 8 – Center Stairwell Column Repair Relocation No. 3**

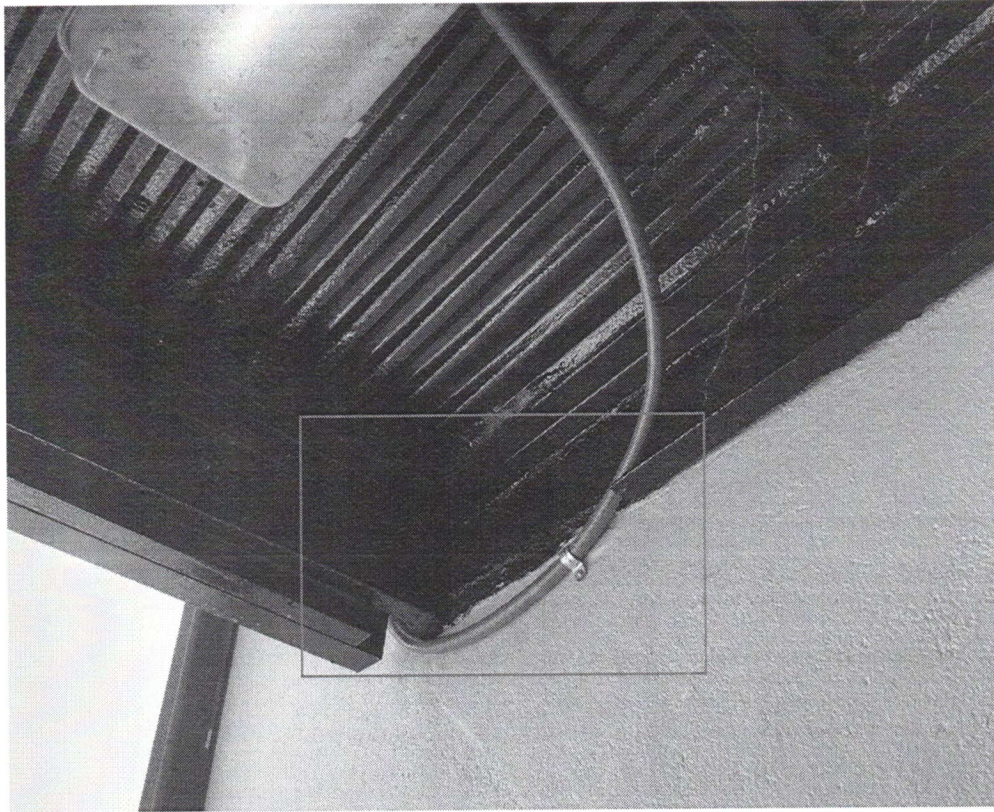
**Photo No. 9 – Center Stairwell Type II Repair**

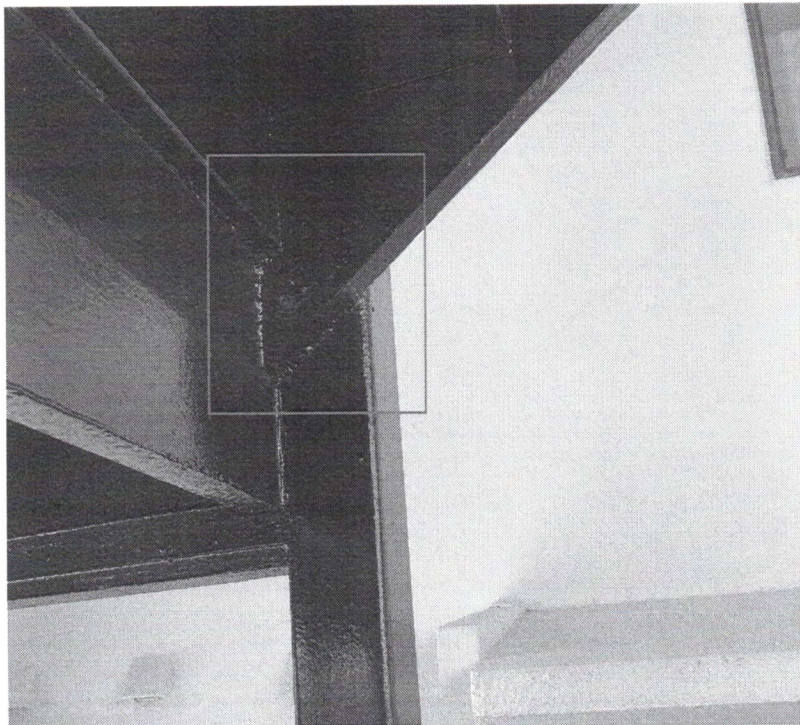
**Photo No. 10 – Center Stairwell Type II Repair**

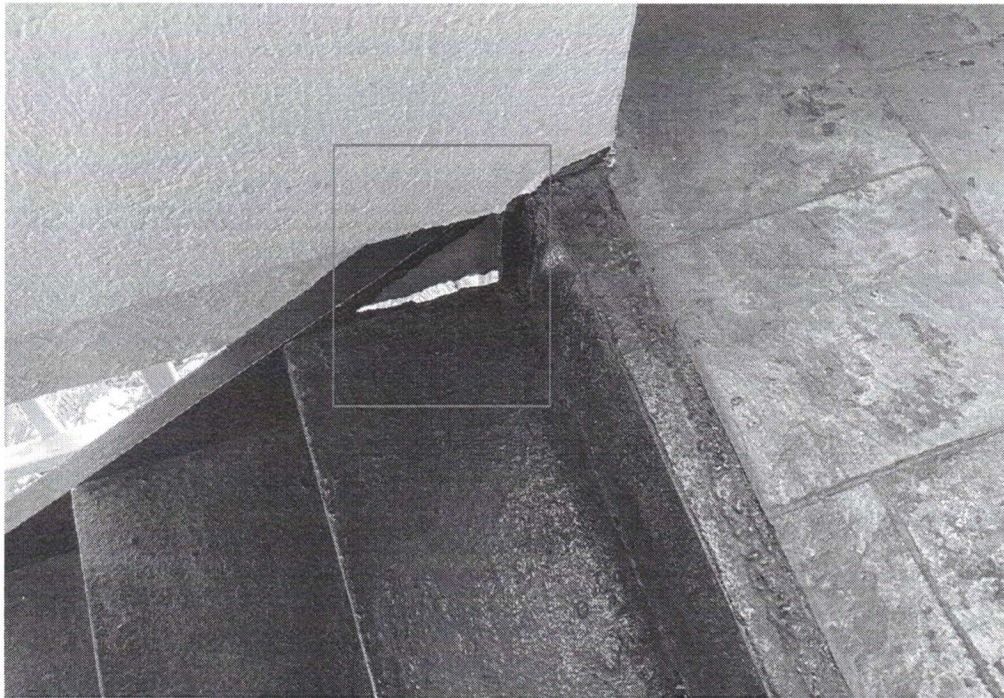
**Photo No. 11 – Center Stairwell Type II Repair**

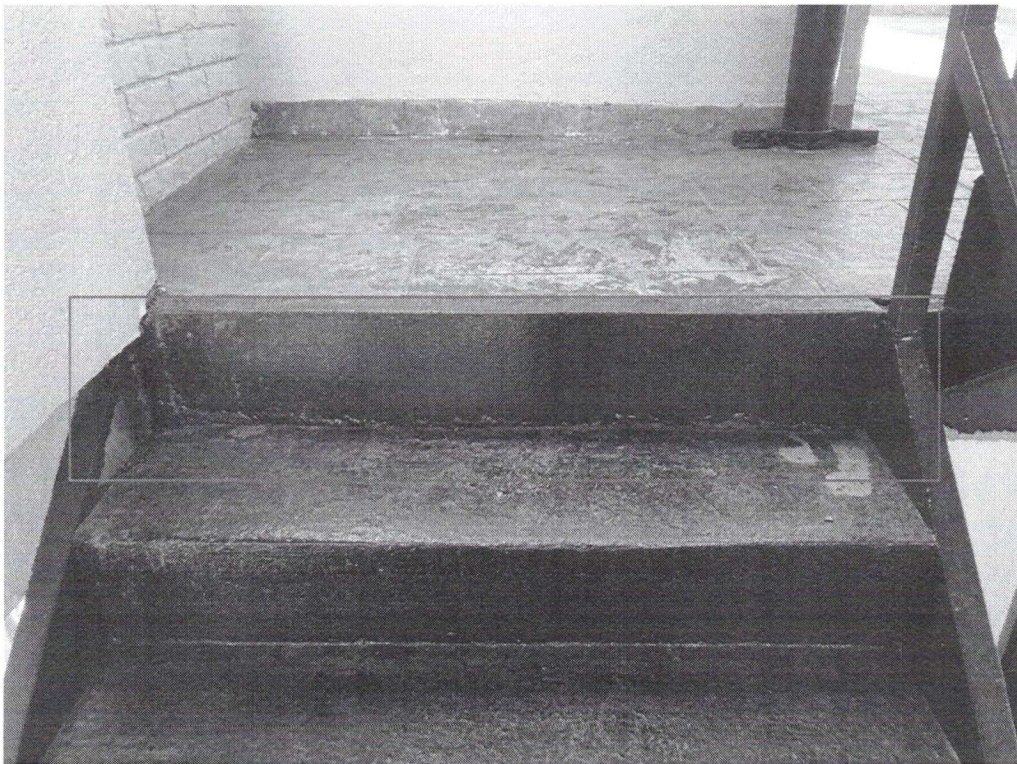
**Photo No. 11 – Center Stairwell Type II Repair**

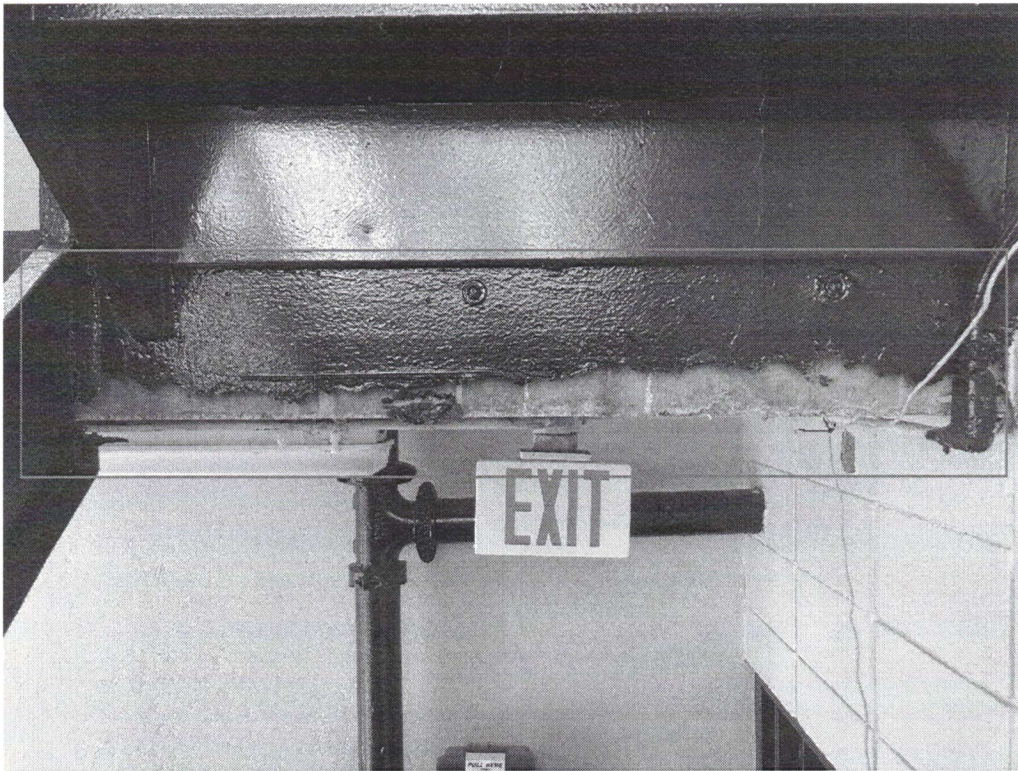
**Photo No. 12 – Center Stairwell Type II Repair**

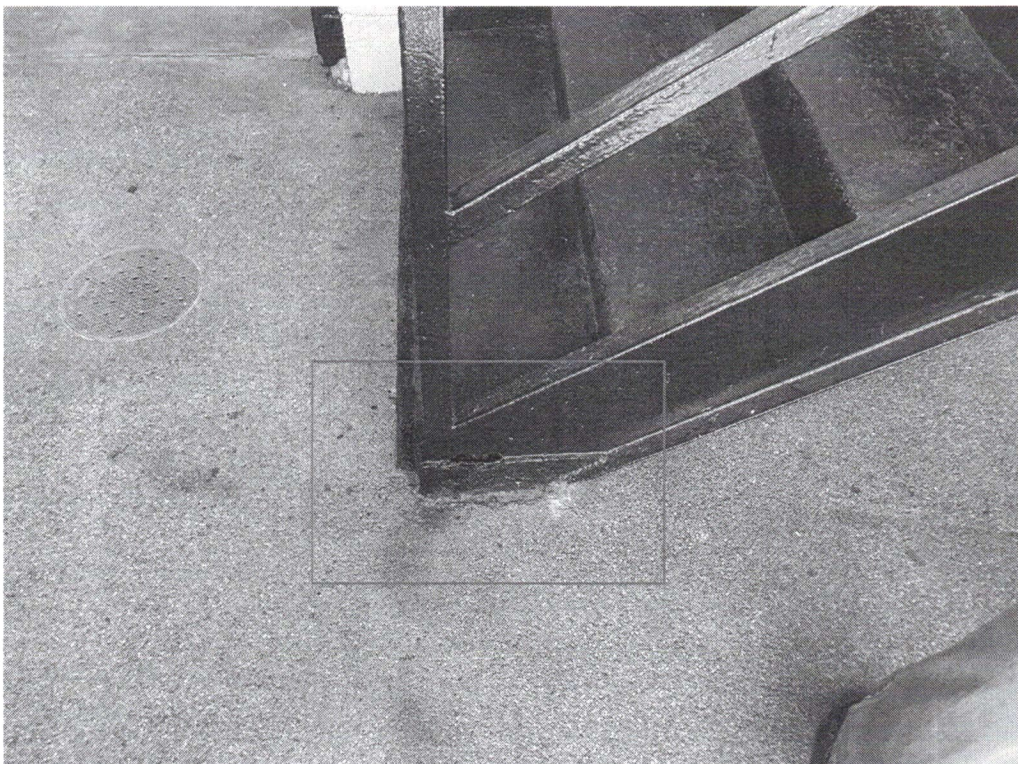
**Photo No. 13 – Center Stairwell Type II Repair**

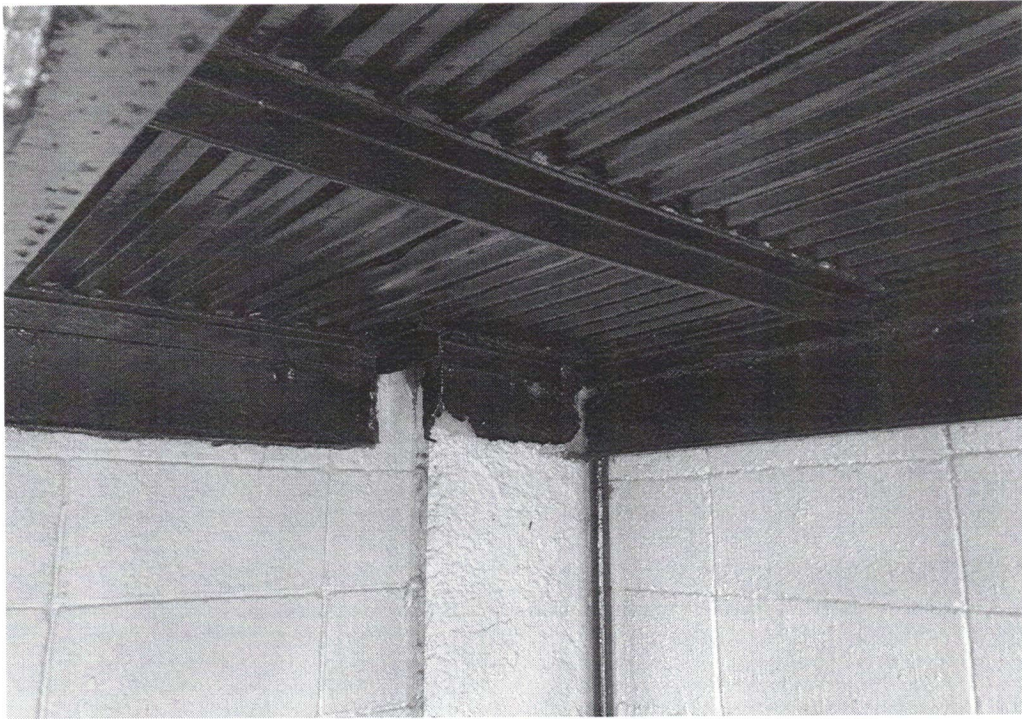
**Photo No. 14 – Center Stairwell Type II Repair**

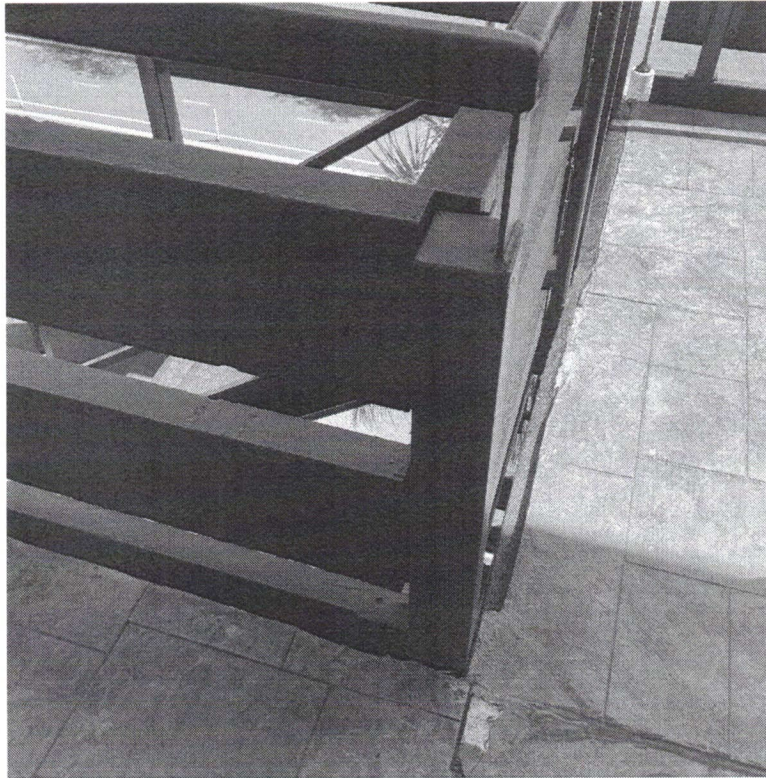
**Photo No. 15 – West Stairwell Column Repair Location No. 4**

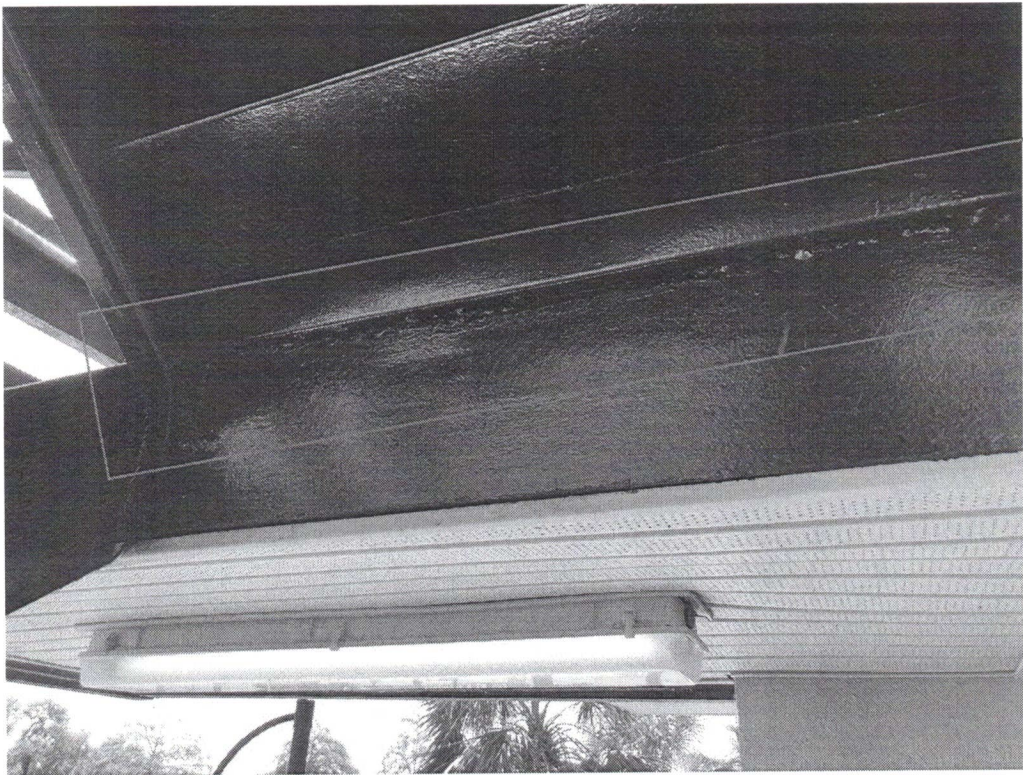
**Photo No. 16 – West Stairwell Type I Repair**

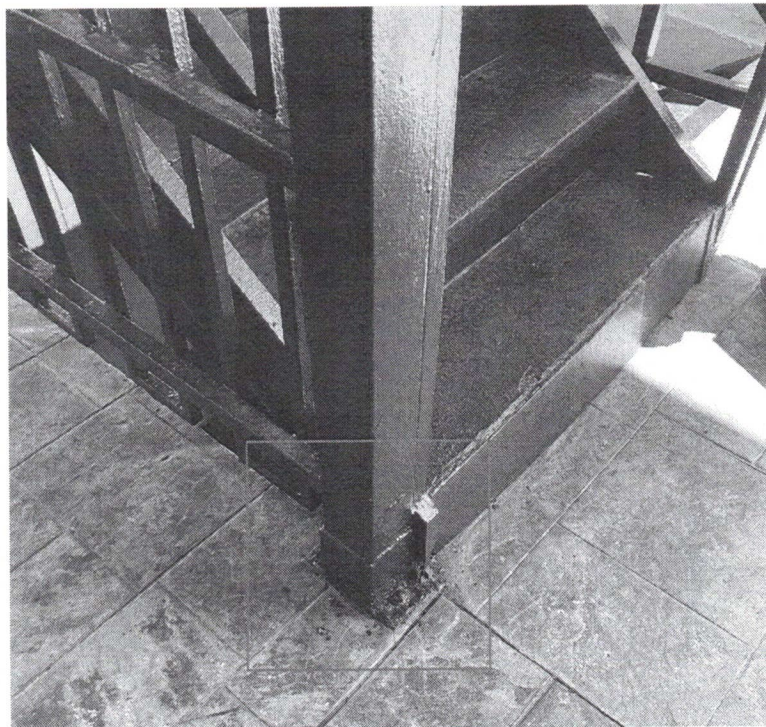
**Photo No. 17 – West Stairwell Type I Repair**

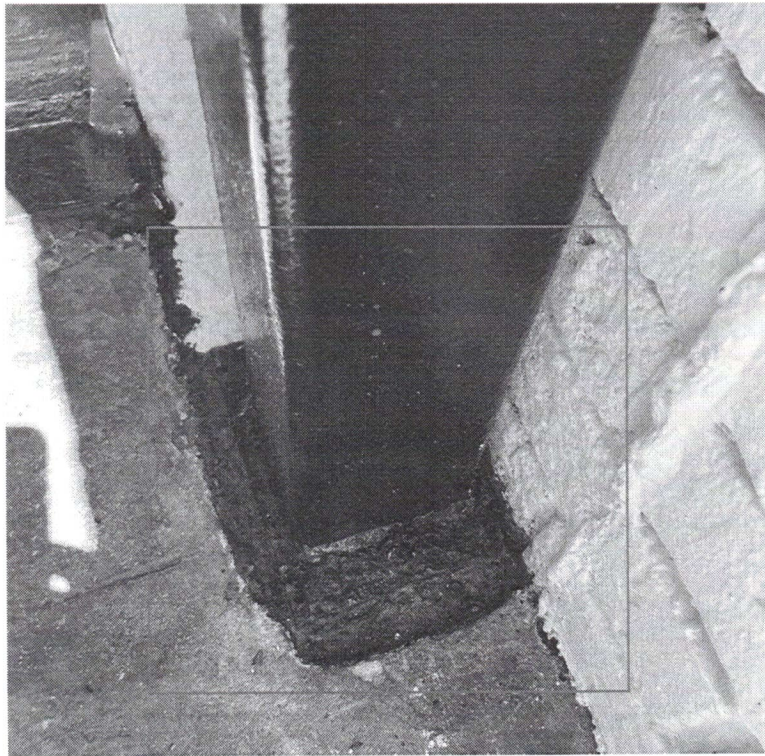
**Photo No. 18 – West Stairwell Type I Repair**

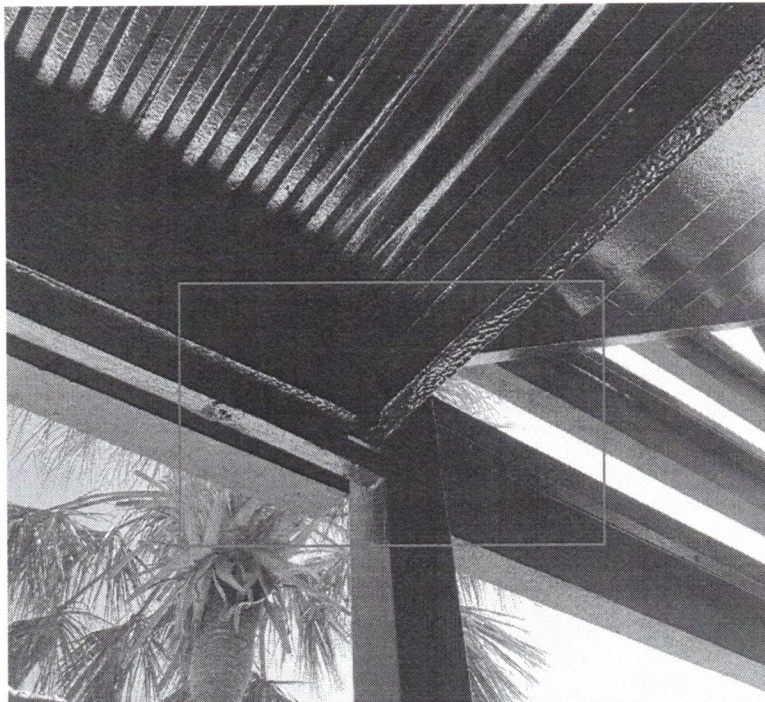
**Photo No. 19 – West Stairwell Type I Repair**

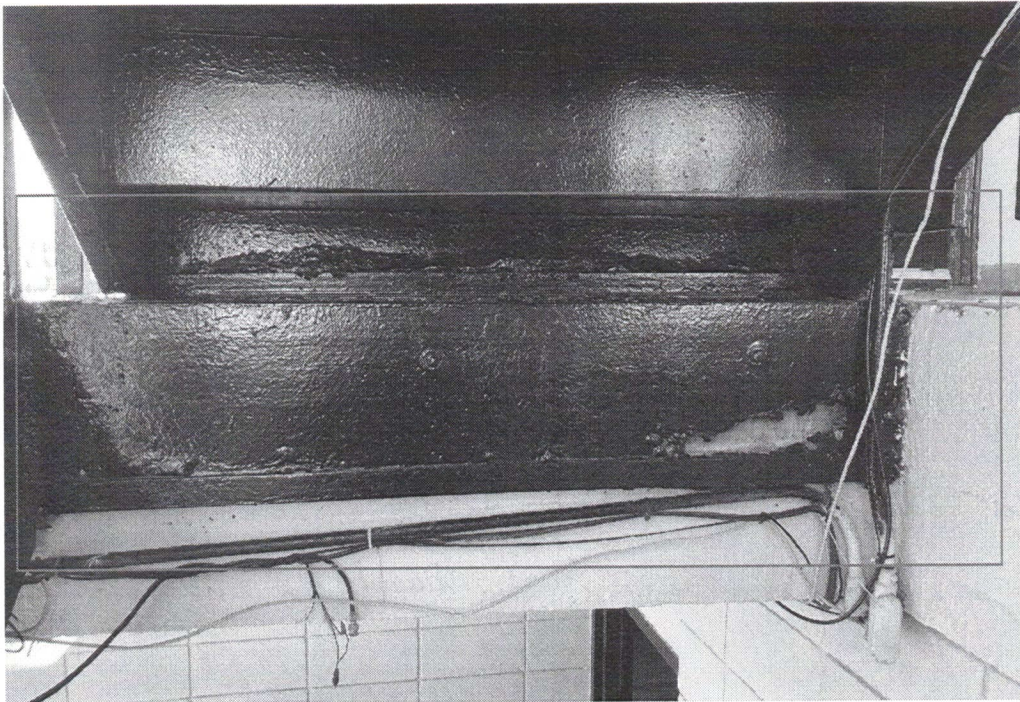
**Photo No. 20 – West Stairwell Type II Repair**

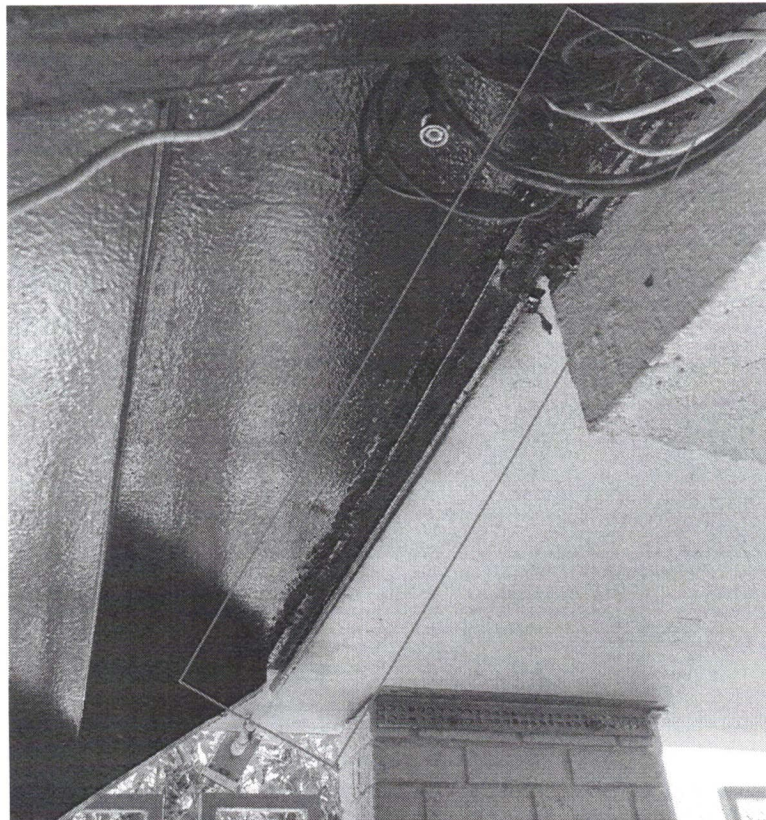
**Photo No. 21 – West Stairwell Type I Repair**

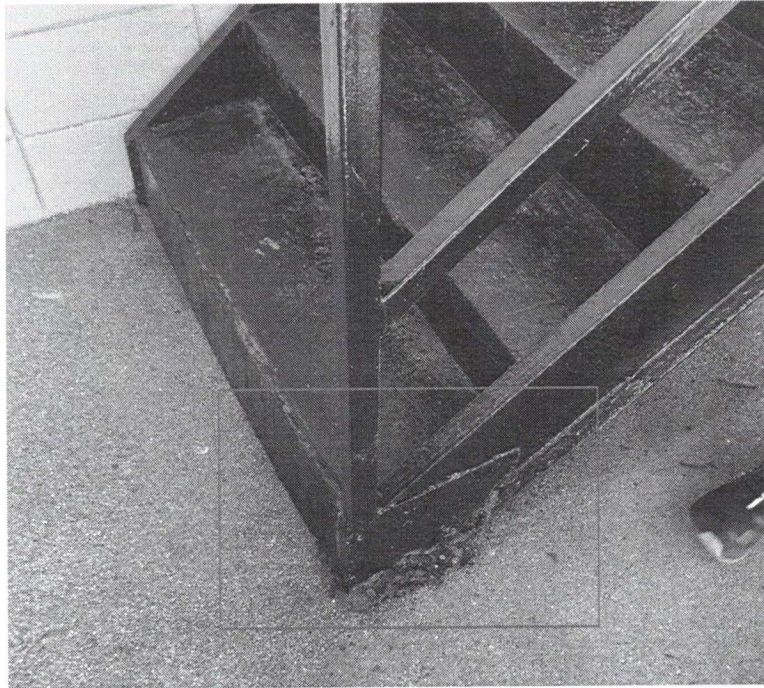
**Photo No. 22 – West Stairwell Type II Repair**

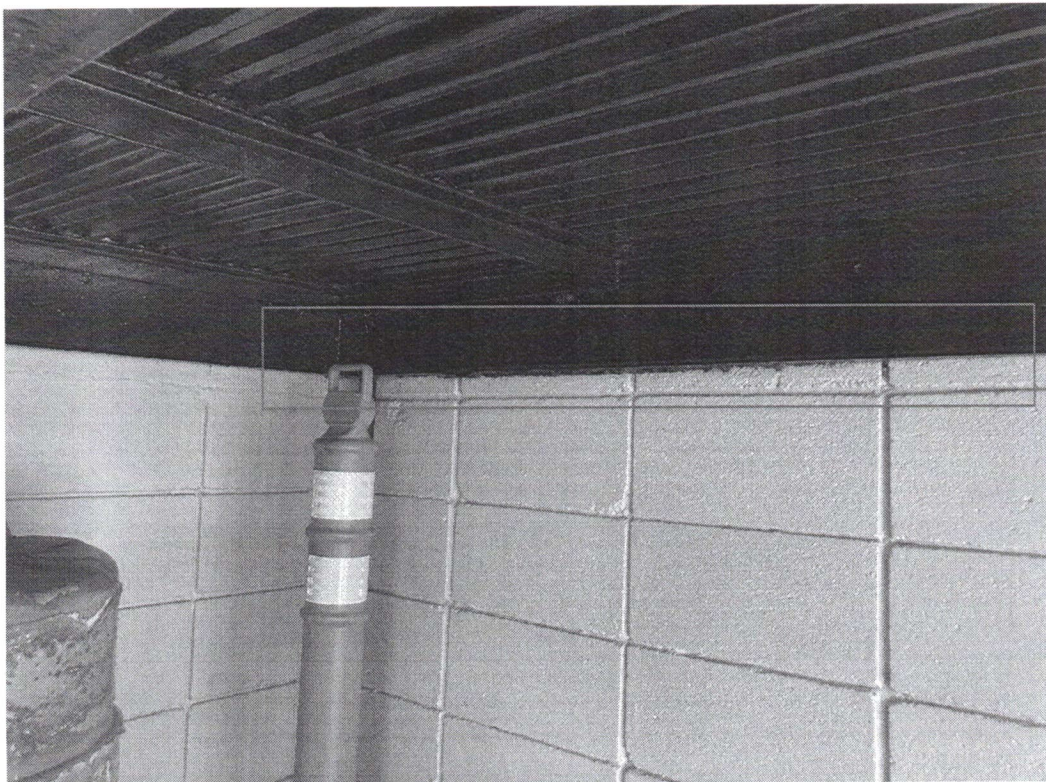
**Photo No. 23 – West Stairwell Type I Repair**

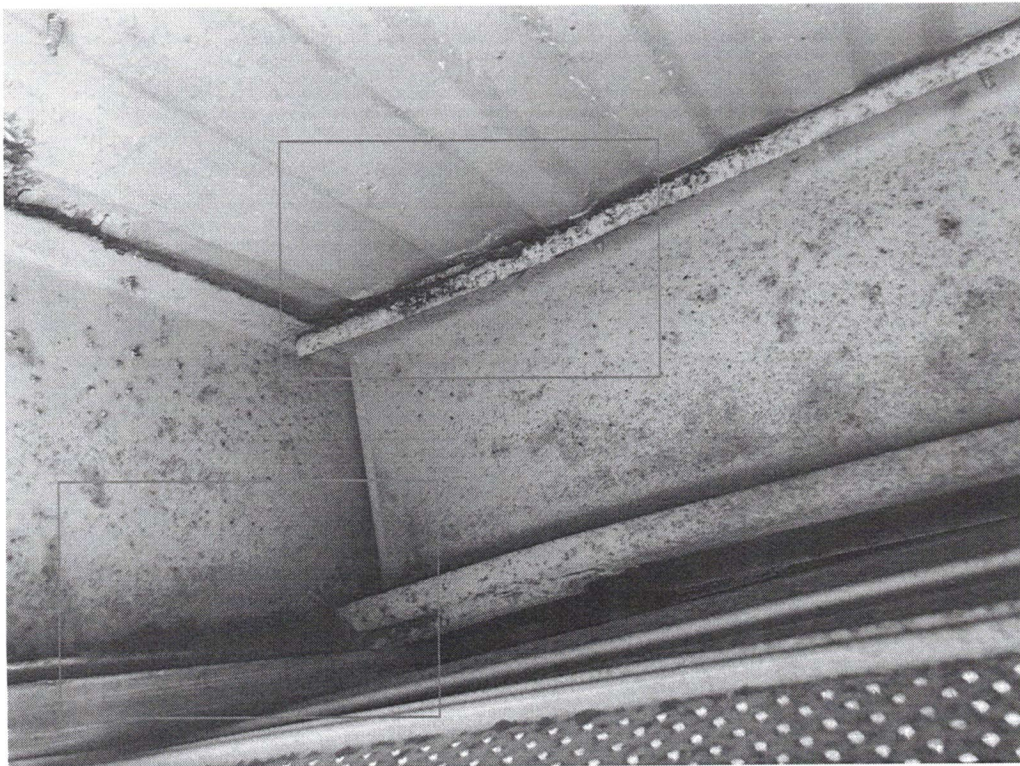
**Photo No. 25 – Deteriorated C-Joist and Rim Joist to be Replaced**

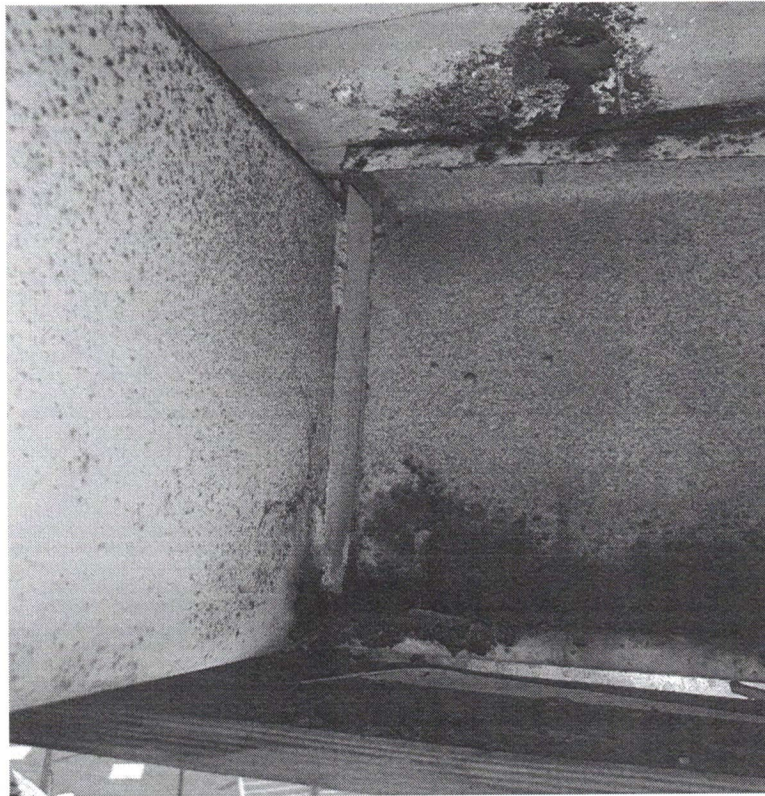
**Photo No. 26 – Deteriorated Rim Joist to be Replaced**
