# INSPECTION OF STAIRWELLS AND 3<sup>rd</sup> FLOOR WALKWAYS FOR LIGHTHOUSE HARBOR CONDOMINIUMS

*October 3, 2022*

Larry M. Oliver Enterprises, Inc. was charged with the task of inspecting the existing stairwells and 3<sup>rd</sup> Floor walkways located at 7300 Lakeshore Drive New Orleans, Louisiana, for Lighthouse Harbor Condominiums.

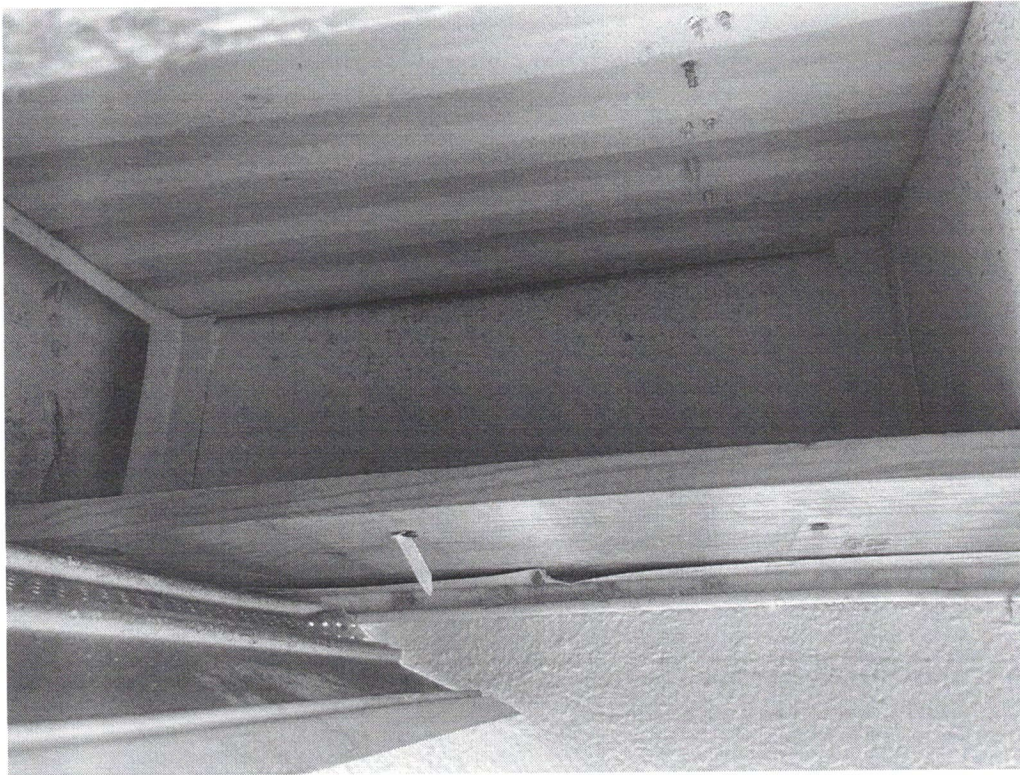
**Photo No. 24 – Typical Section at East Exterior Wall**

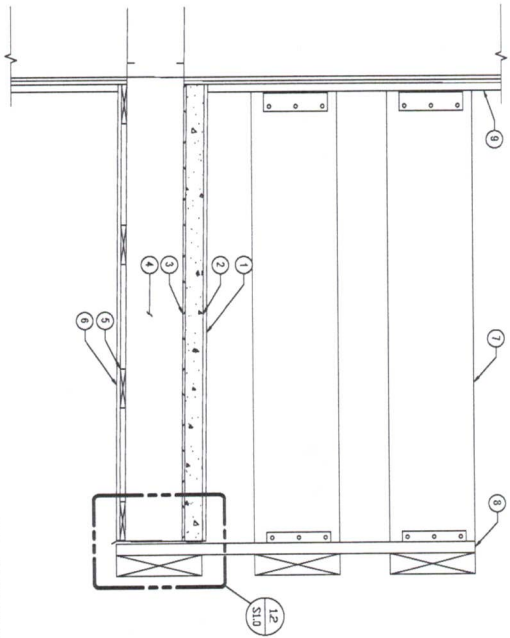
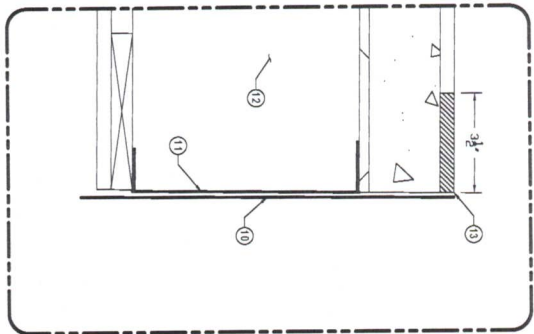
1.1 DEMOLITION PLAN OF EXISTING BALCONY EDGE FLASHING  
VARIES

The engineers inspected the 3<sup>rd</sup> level balcony components in various areas to evaluate their conditions. It was determined that the existing edge flashing is no longer serving its designed purpose and should be replaced in its entirety. Refer to details provided for repair procedure. The exterior rim track that spans North and South on the balcony has significant deterioration in various sections and should be replaced in its entirety or as determined by the engineer. Refer to details below for repair procedure. It was observed that various C-joist members have significant corrosion present in the top and bottom flanges. It is estimated that approximately 50 members will require a splice repair as shown in the details below. The engineers removed the soffit from the 3<sup>rd</sup> floor balcony. This was done adjacent to the exterior wall of Unit 23. It was observed that there was no vapor or air barrier installed along the exterior wall at the balcony soffit line. It is recommended that all soffits be removed, and a vapor and air barrier be installed per the details included below. This should be installed for the full length of the building. Refer to images below.
